Appendix C

Photo Logs – Test Trenches, Soil Borings

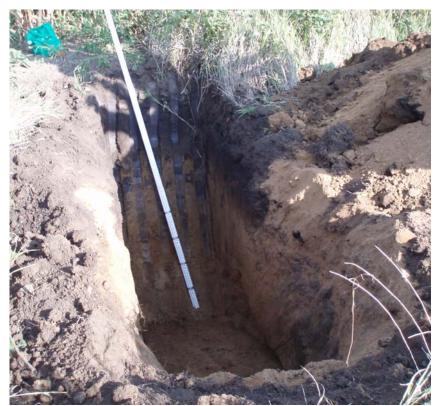
Photo 1 Test trench SOC4-TT1.

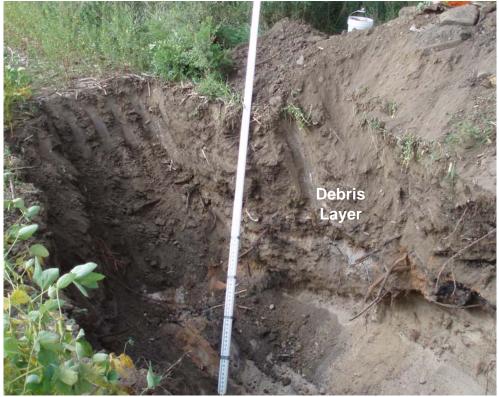
Photo 2 Test trench SOC4-TT9, debris encountered.

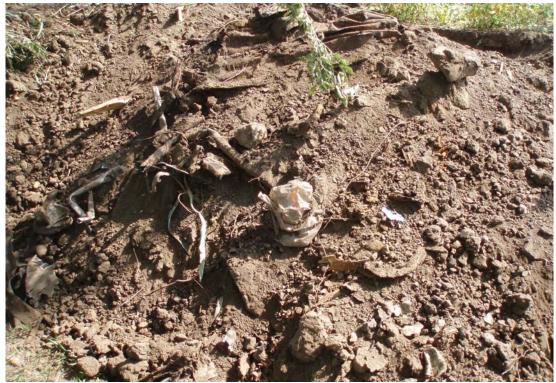
Photo 3 Spoil pile from test trench SOC4-TT9. Debris encountered included concrete, plastic, metal, glass, ash, shingles and tiles.

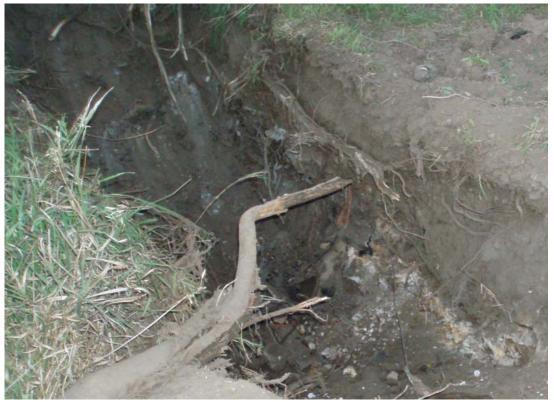
Photo 4 Test trench SOC4-TT9B, debris encountered.

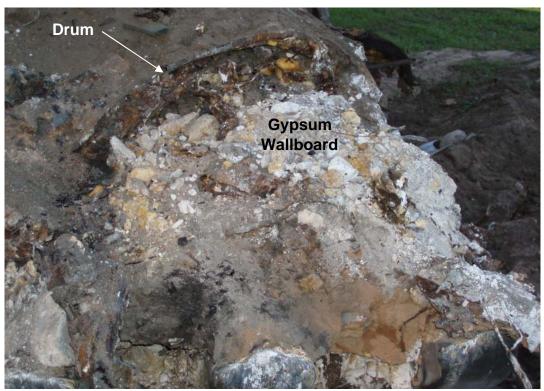
Photo 5 35-gallon drum containing gypsum wallboard found in test trench SOC4-TT9B.

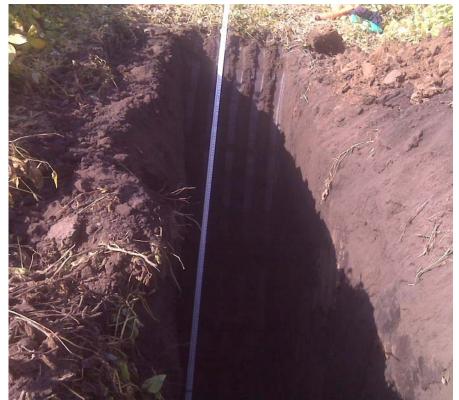
Photo 6 Test trench SOC4-TT12. Analytical soil sample SOC4-TT12-0.5' was collected from 0.5 feet below ground surface in this test trench.

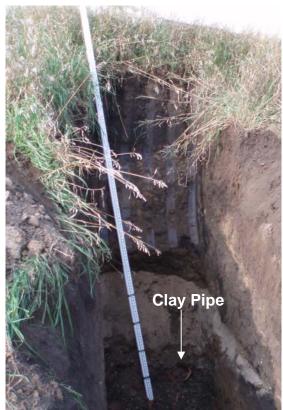
Photo 7 Test trench SOC5-TT17.

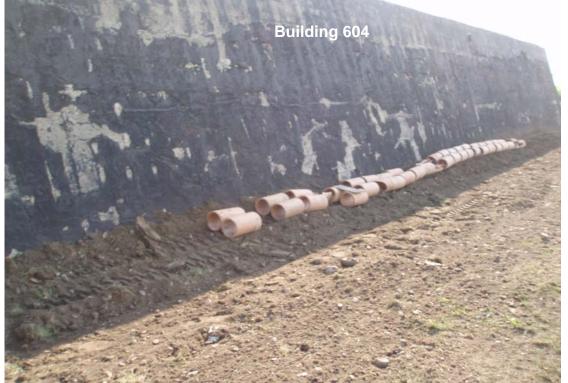
Photo 8 Tar coating on DNT storage bunker 260-H (Bld. 604) and drainage tile removed from the perimeter of the building.

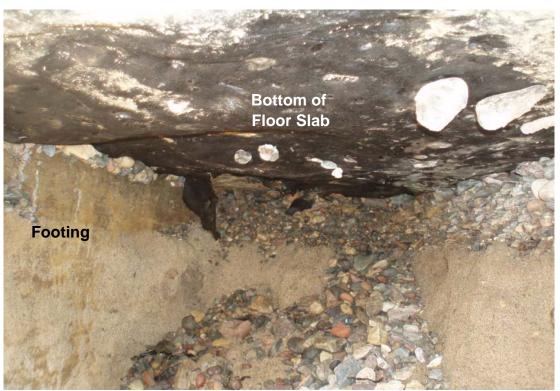
Photo 9 Tar coating and poorly graded gravel layer below the floor slab at DNT storage bunker 260-H (Bld. 604).

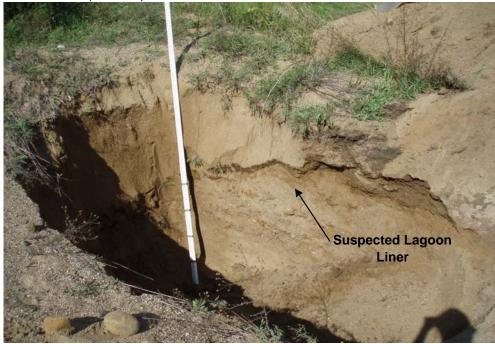
Photo 10 Test trench SOC5-TT29 in the former rinsate lagoon. Lagoon liner was observed in this test trench.

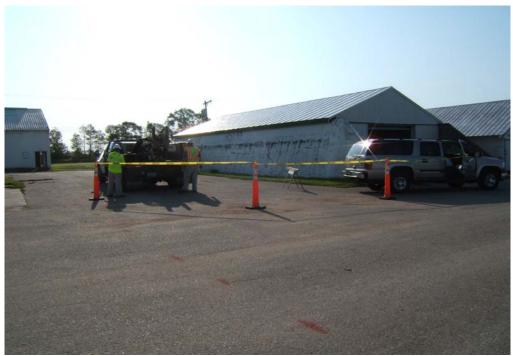
Photo 11 Work zone delineation at SOC5-GP6

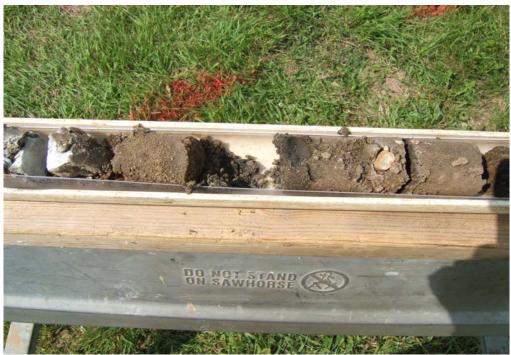
Photo 12 Stained soils at SOC5-GP8

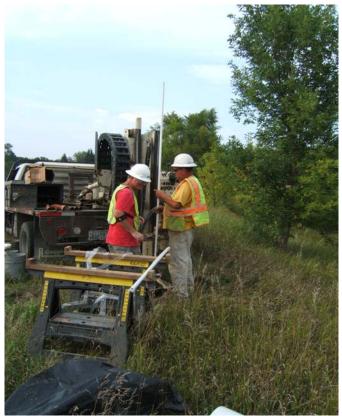
Photo 13 Temporary well installation at SOC4-GP1

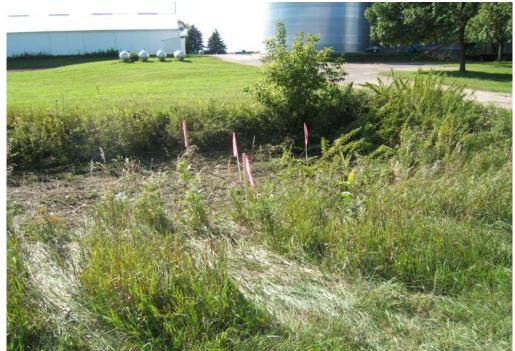
Photo 14 Pesticide sampling borings at SOC5-GP13, locations A through D

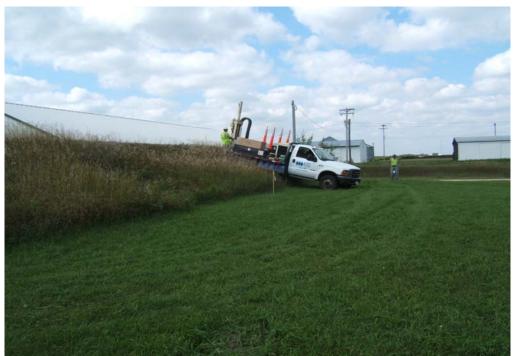
Photo 15 Drilling on the DNT storage bunker berm at SOC5-GP21

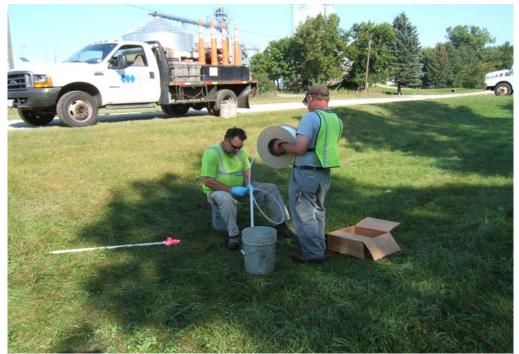
Photo 16 Groundwater sampling at SOC5-GP3
