Building 101B, East Guncotton/Nitrocellulose Production Area (A, B,C Lines)

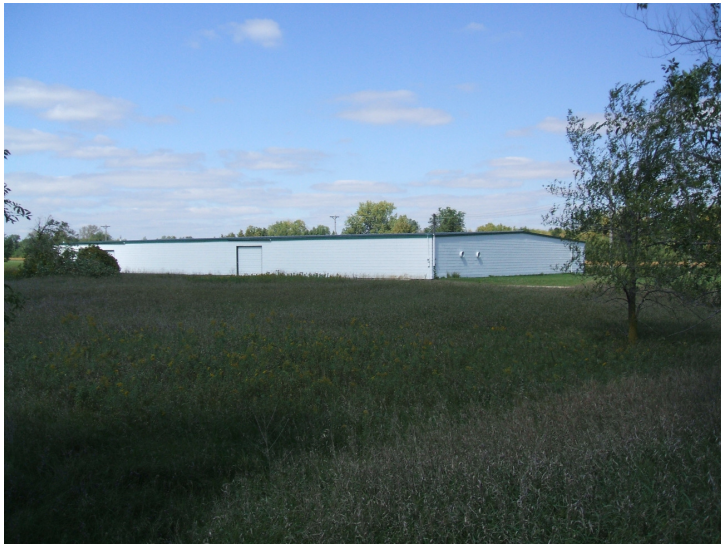
9/20/06: view facing northwest.

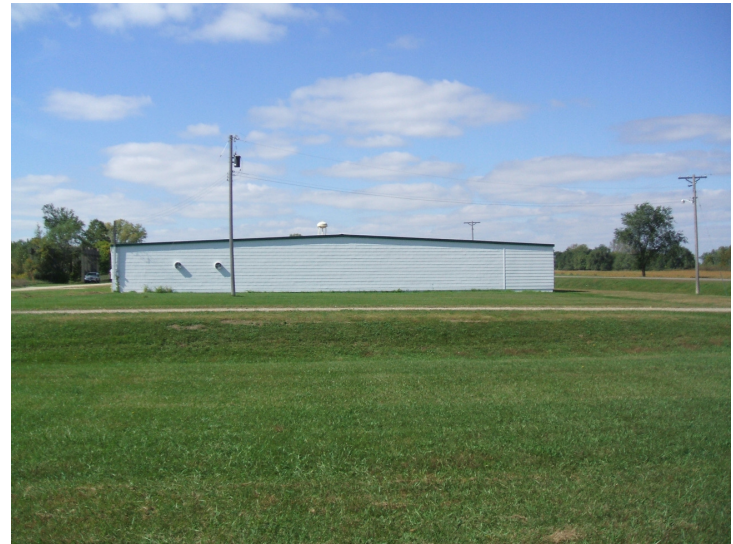
9/20/06: view facing west.

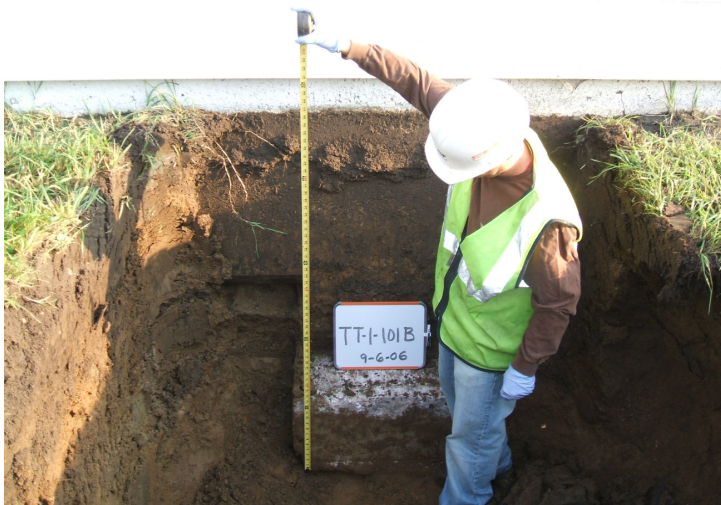
9/6/06: concrete footing in test trench 1, located in the southeast corner of the building.

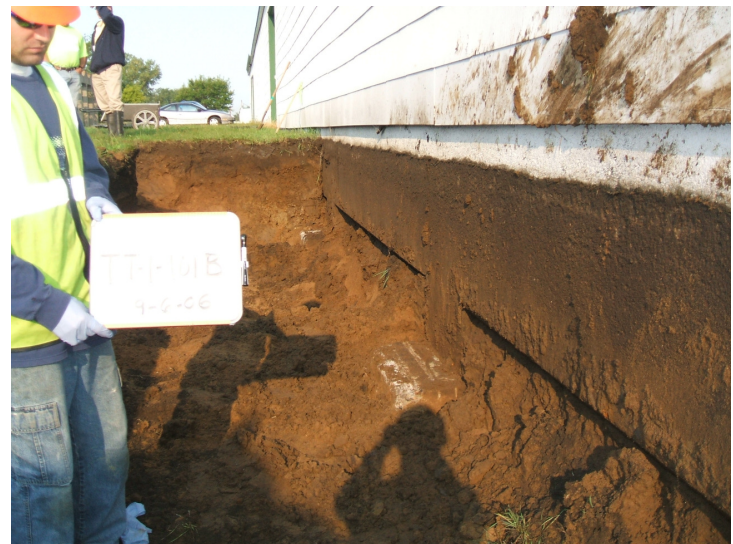
9/6/06: test trench 1 facing west.

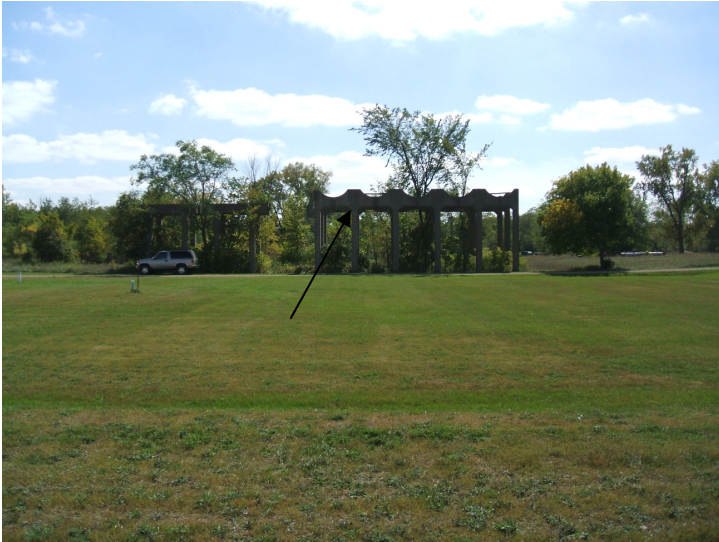
9/20/06: view facing south of concrete remnant of the building.

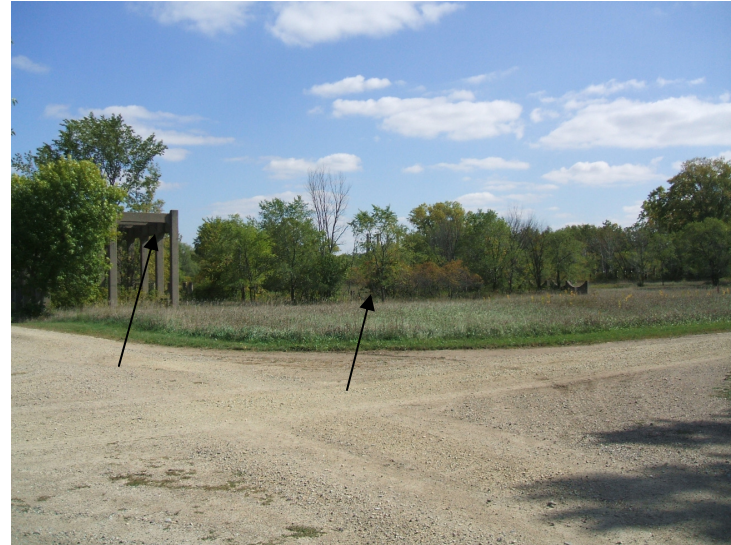
9/20/06: view facing southeast of concrete remnant and footing locations hidden by trees.

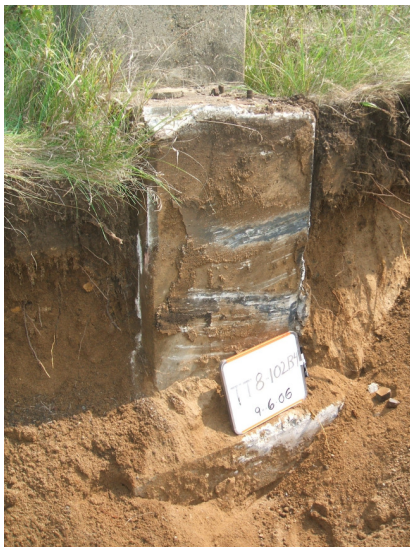
9/6/06: concrete footing in test trench 8.

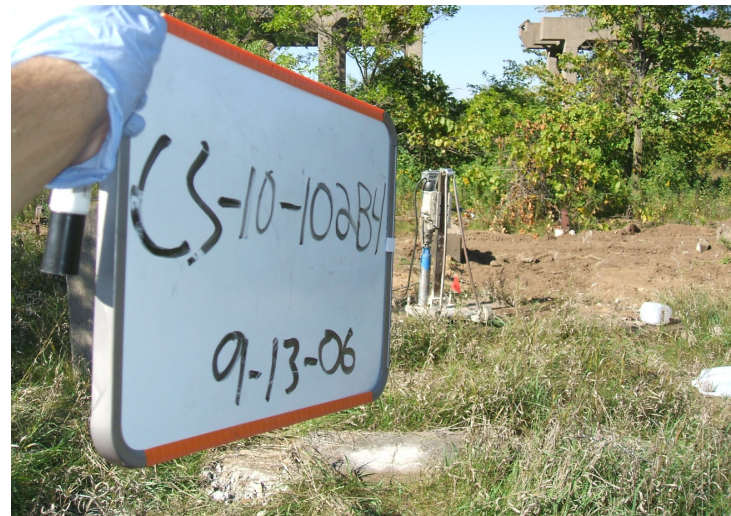
9/13/06: facing north, location of concrete sample 10 on concrete footing piece.

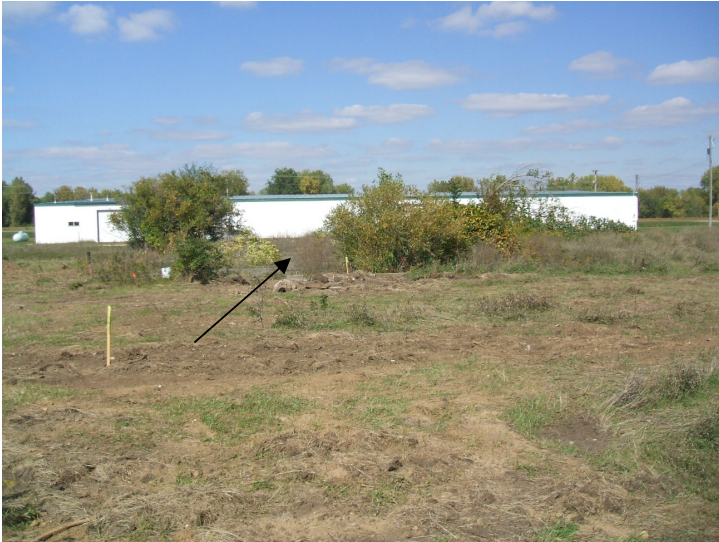
9/20/06: view facing north of concrete building pad location framed out by bushes.

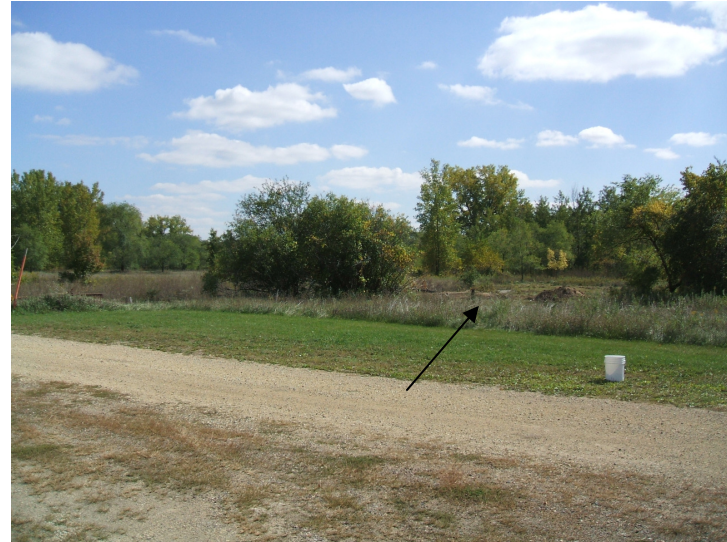
9/20/06: view facing southeast of concrete building pad hidden by foliage.

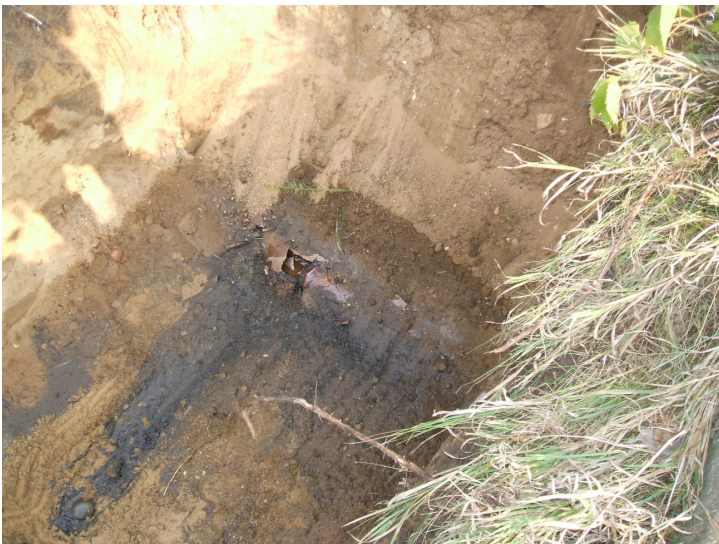
9/6/06: clay pipe discovered in test trench 2 located along the west central part of western building wall.

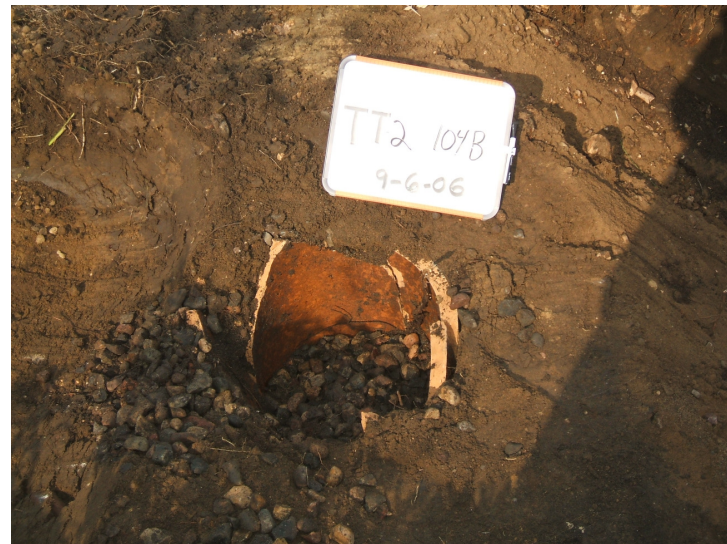
9/6/06: dry well discovered in test trench 2 located a few feet south of the clay pipe that was discovered.

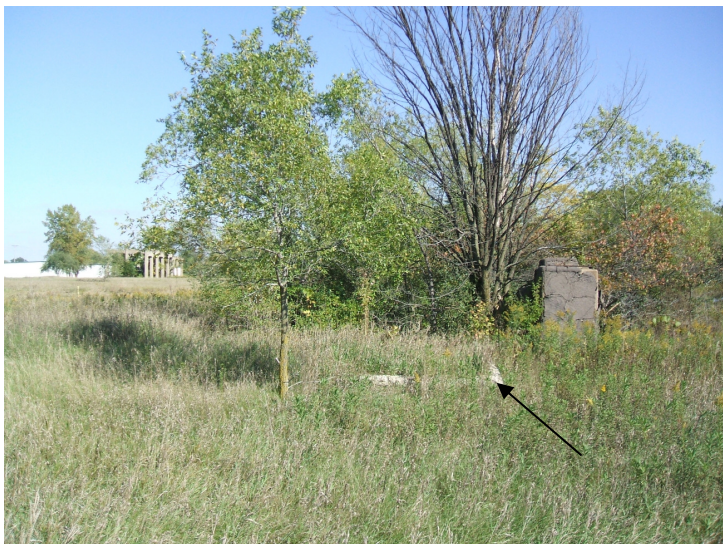
9/20/06: view facing east of building pad.

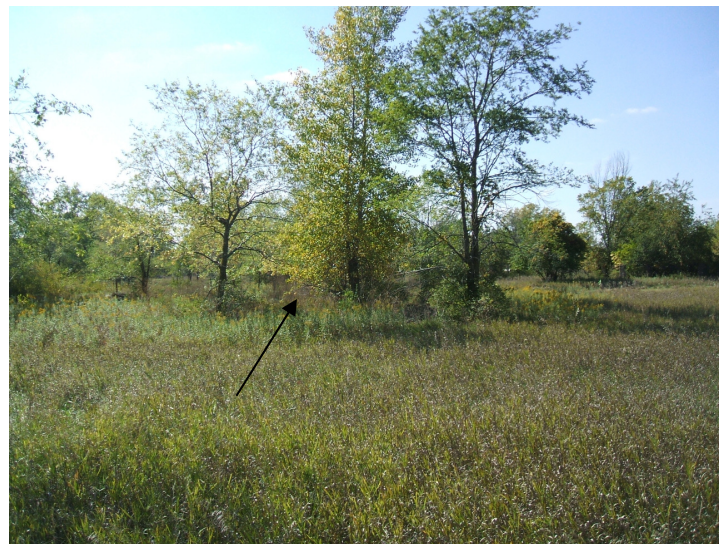
9/20/06: view facing west of building pad hidden by trees.

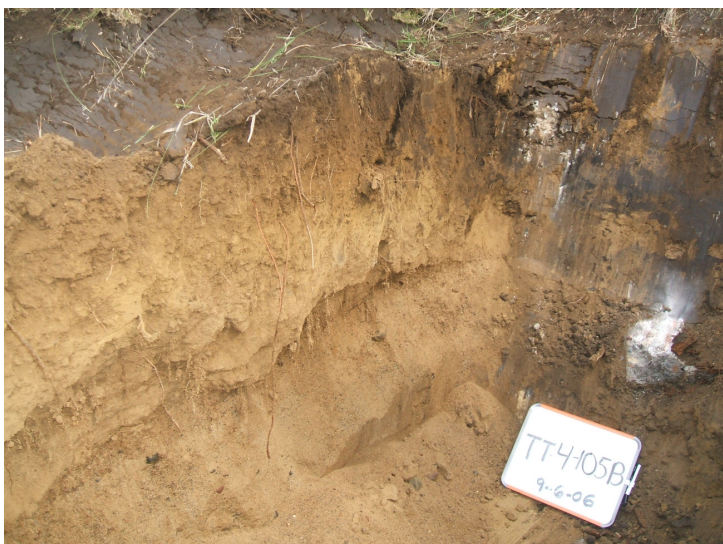
9/6/06: test trench 4 located on the north side of the building.

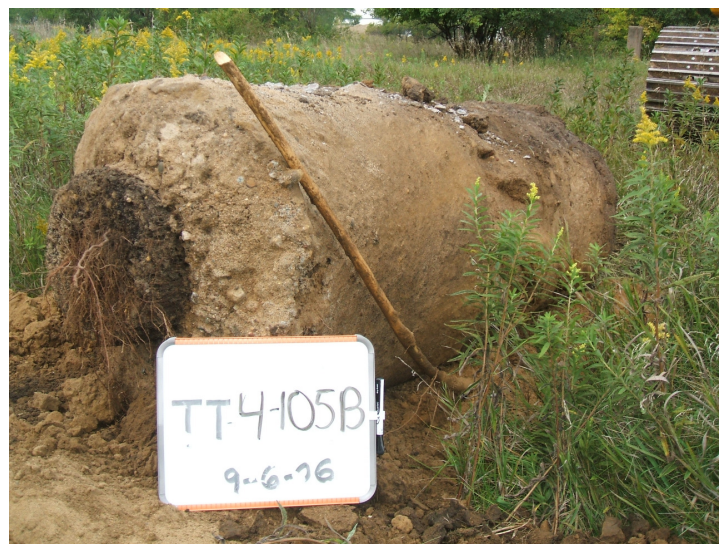
9/6/06: concrete footing with wooden pole in test trench 4.

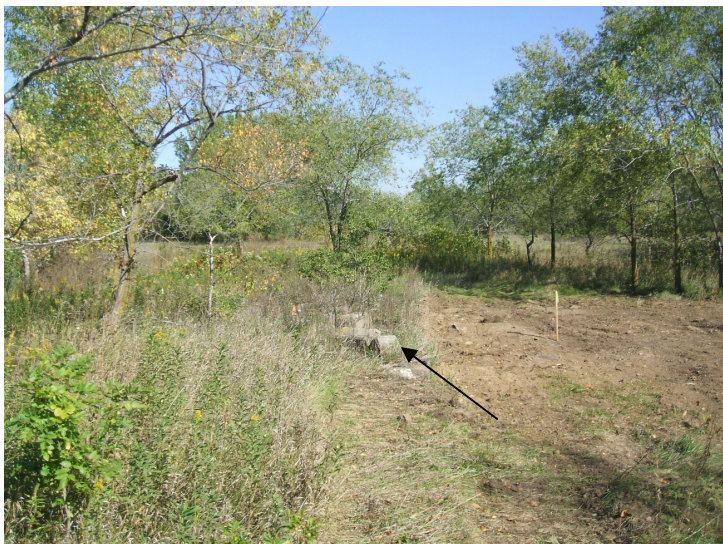
9/20/06: view facing east of concrete building pad.

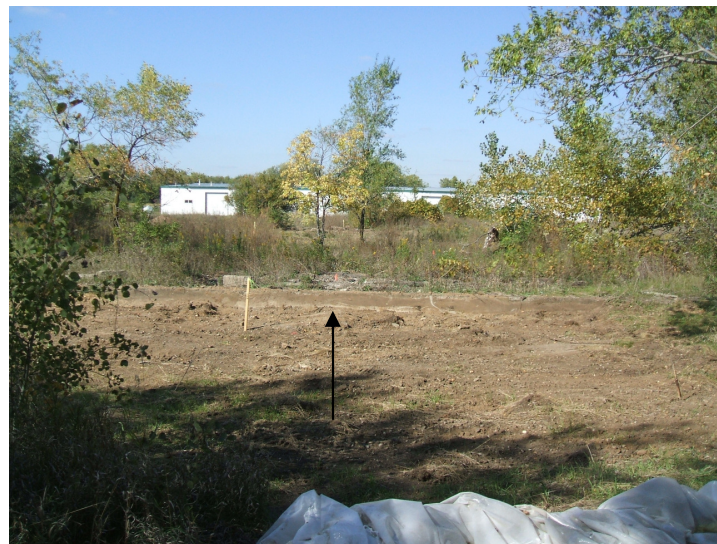
9/20/06: view facing north of concrete building pad.

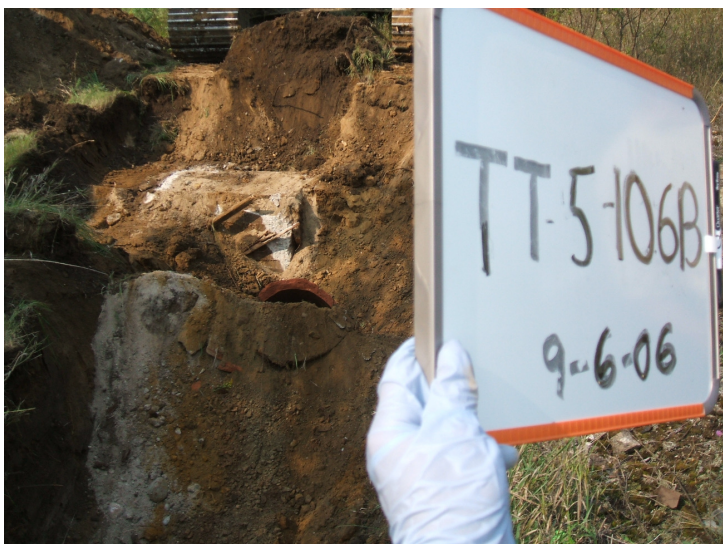
9/6/06: concrete footing and clay pipe in test trench 5 located on south side of the building.

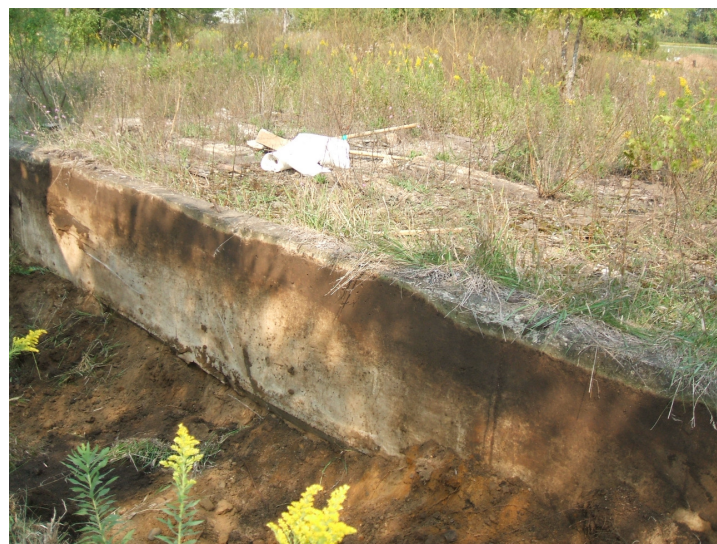
9/6/06: concrete footing along test trench 5 along south side of the building.

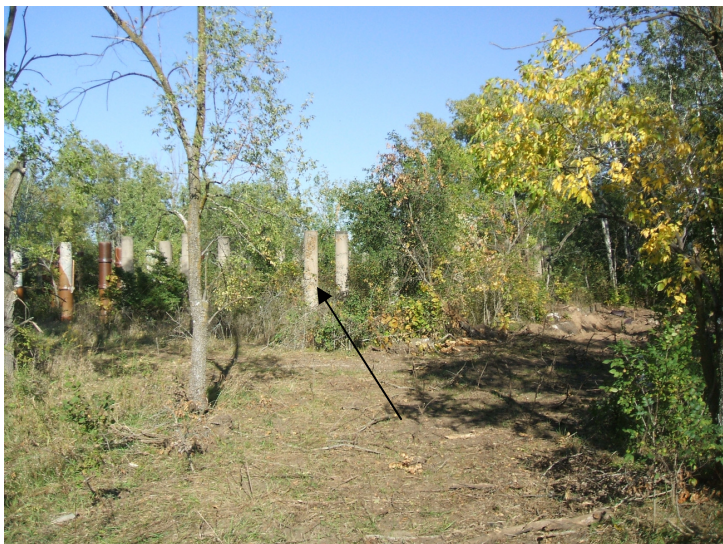
9/20/06: view facing northeast of pillars standing on the concrete building pad.

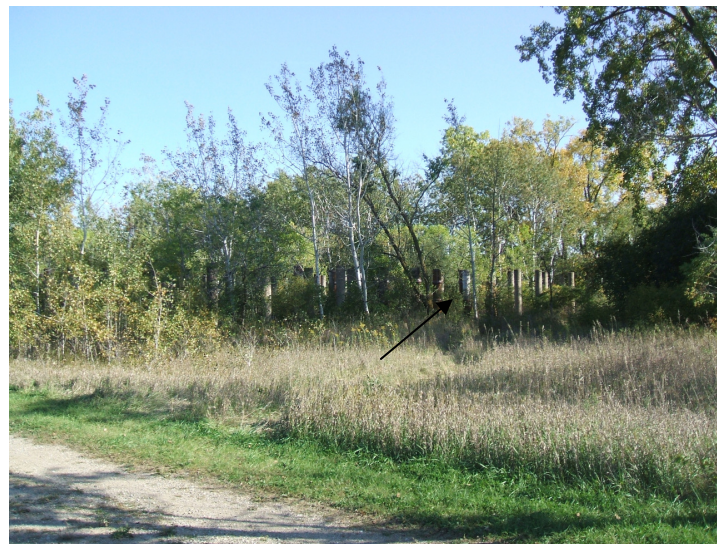
9/20/06: view facing southeast of pillars in the trees standing on the concrete building pad.

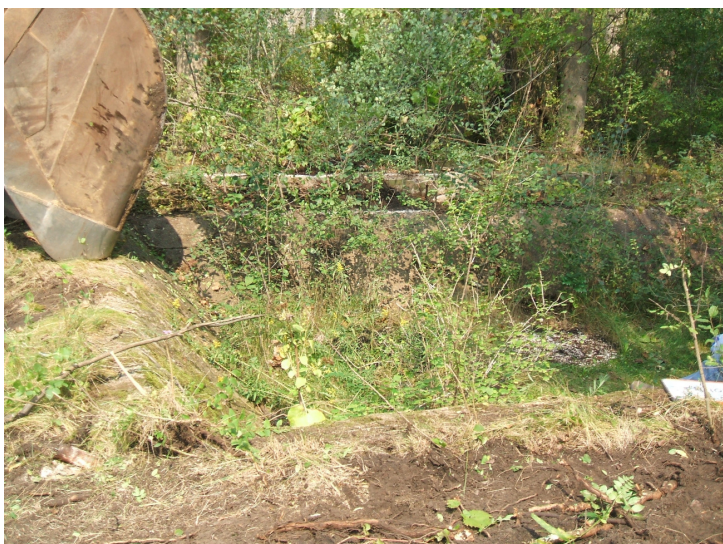
9/6/06: test trench 9 located in the south western portion of the south building wall near a save-all.

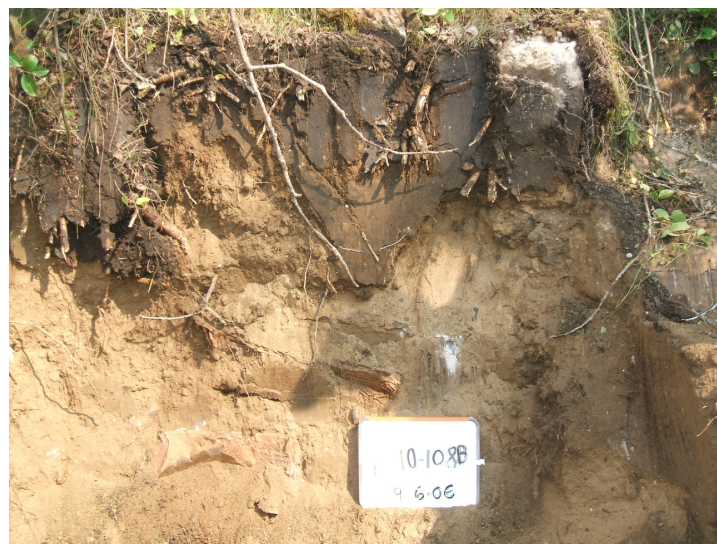
9/6/06: test trench 10 located in the south eastern portion of the south building wall.

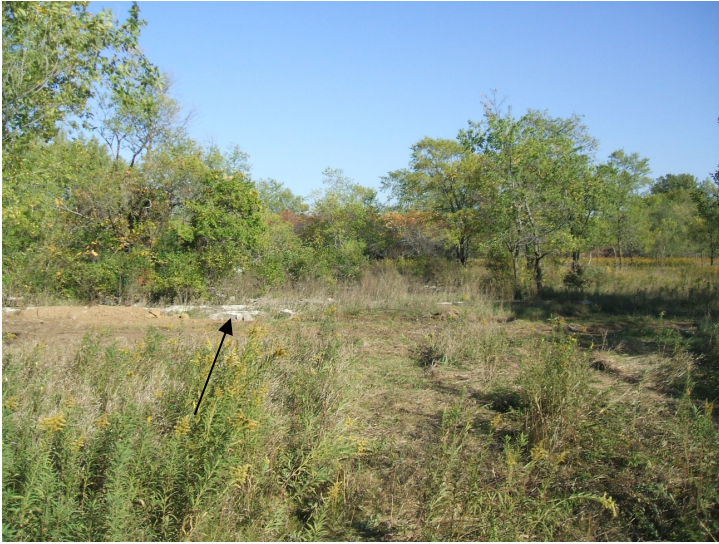
9/20/06: view facing east of concrete building pad.

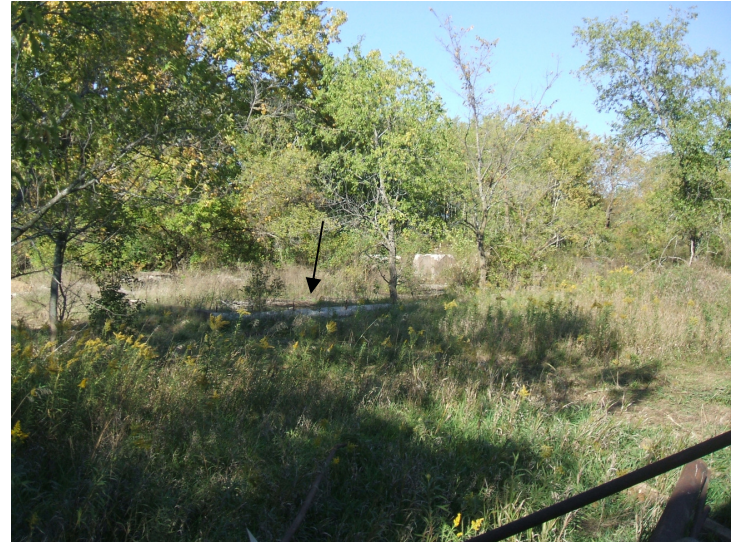
9/20/06: view facing northeast of concrete building pad.

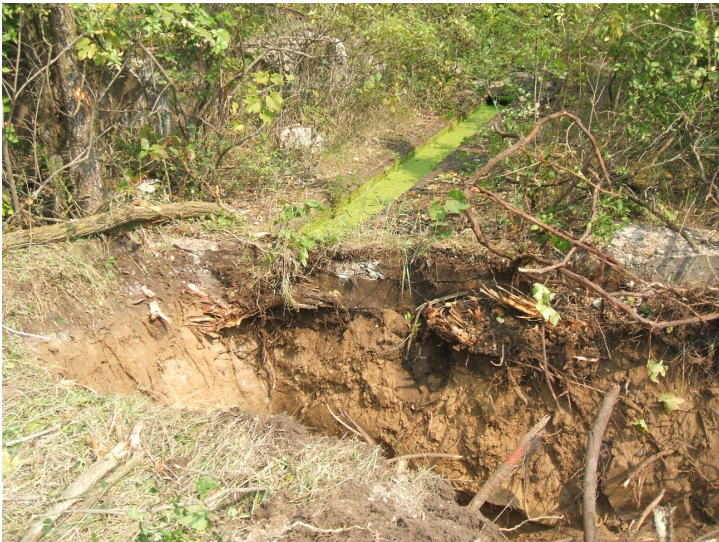
9/6/06: test trench 11 located along the central portion of the west building wall.

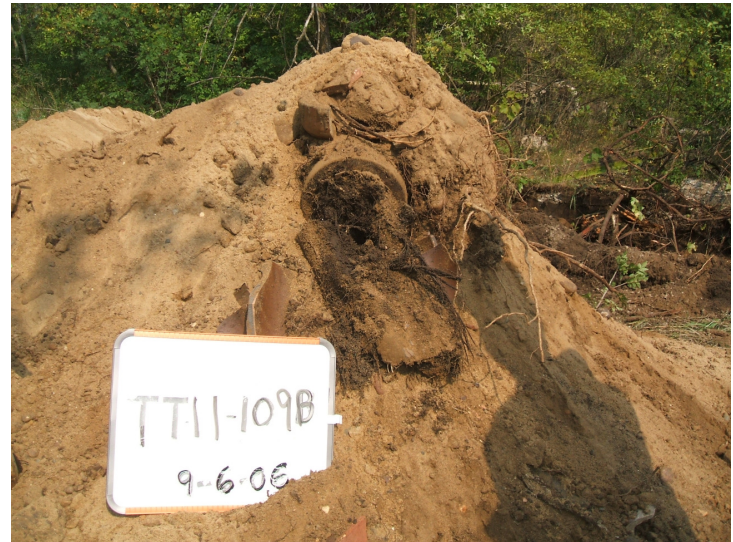
9/6/06: clay pipe discovered in test trench 11.

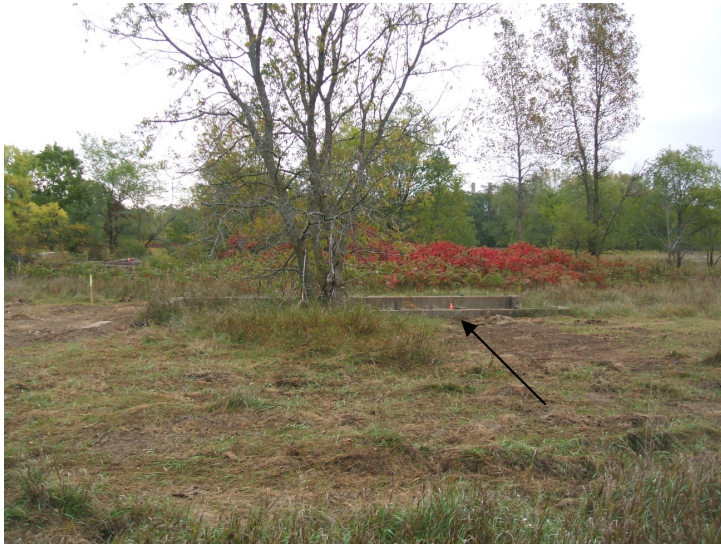
9/21/06: view facing east of concrete building pad.

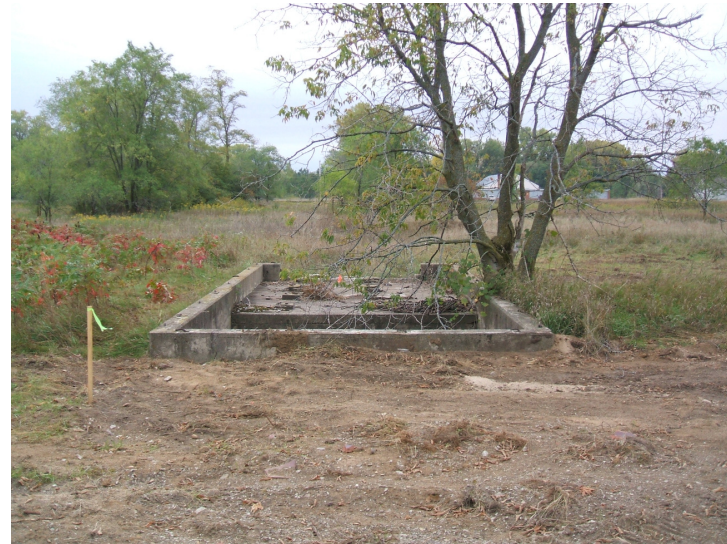
9/21/06: view facing south of concrete building pad.

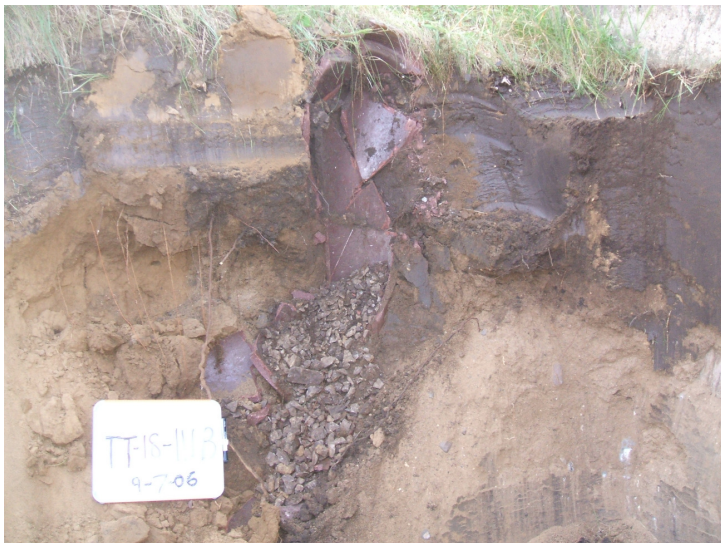
9/7/06: dry well discovered in test trench 18 located on the north side of the building.

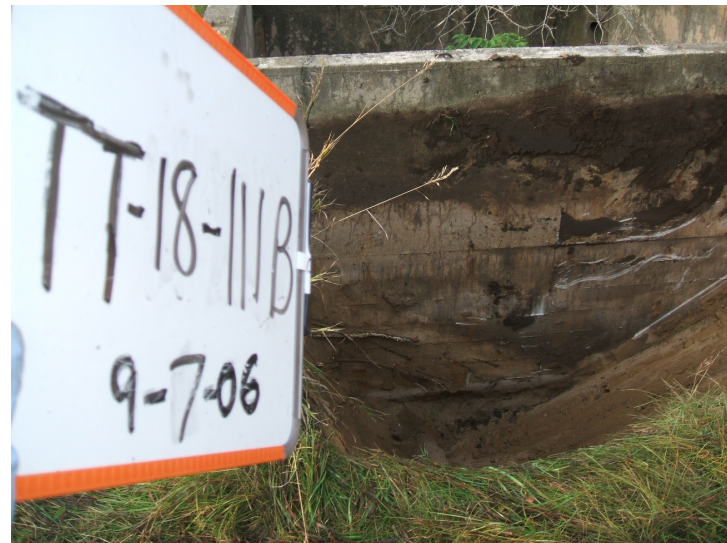
9/7/06: building footing along test trench 18 located on the north side of the building.

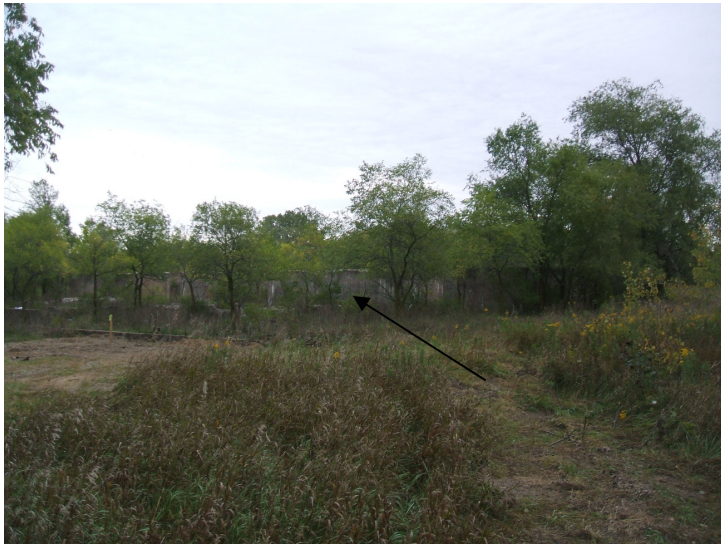
9/21/06: view facing northeast of concrete supports on the concrete building pad.

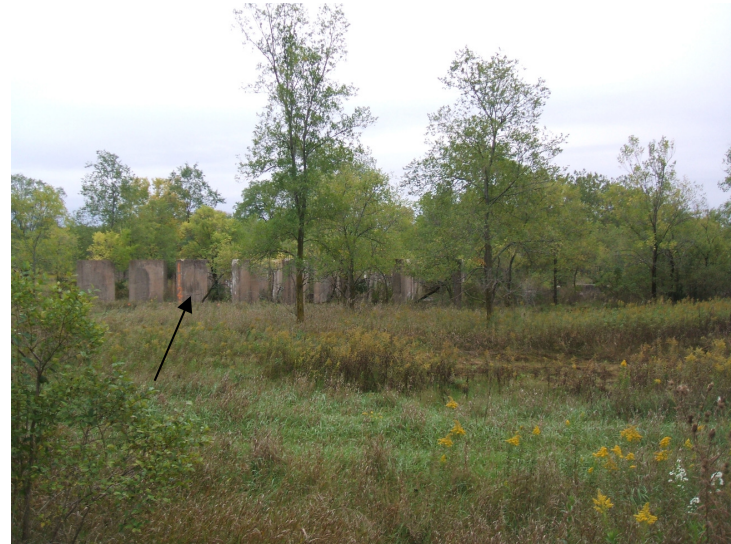
9/21/06: view facing south of concrete supports on the concrete building pad.

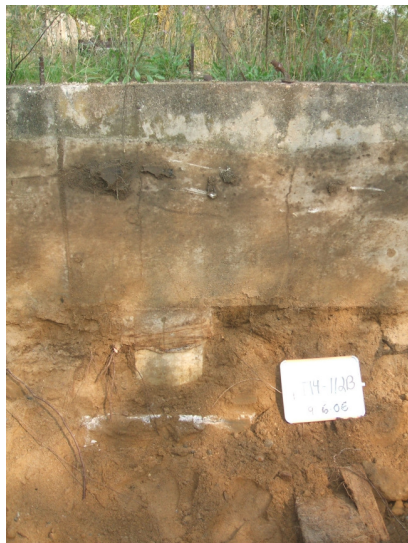
9/6/06: building footing along test trench 14 located along the southern area of the west building wall.

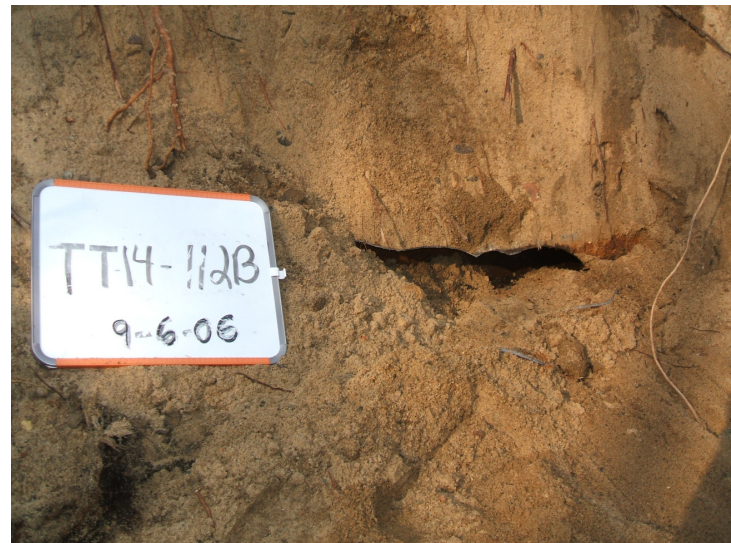
9/6/06: cast iron pipe discovered in test trench 14 located along the southern area of the west building wall.

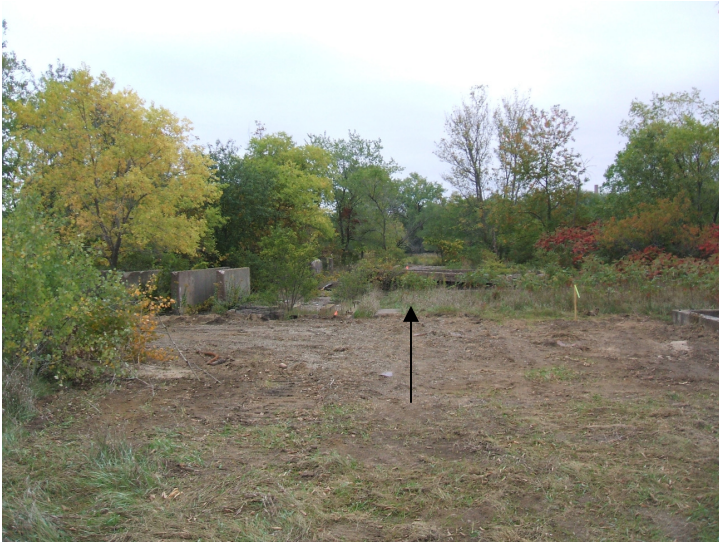
9/21/06: view facing east of concrete building pad and concrete supports.

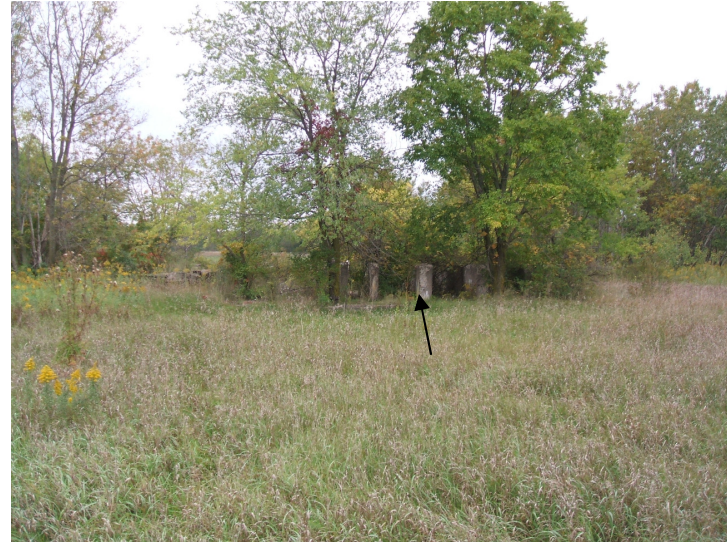
9/21/06: view facing west of concrete supports on building pad. Pad hidden by foliage.

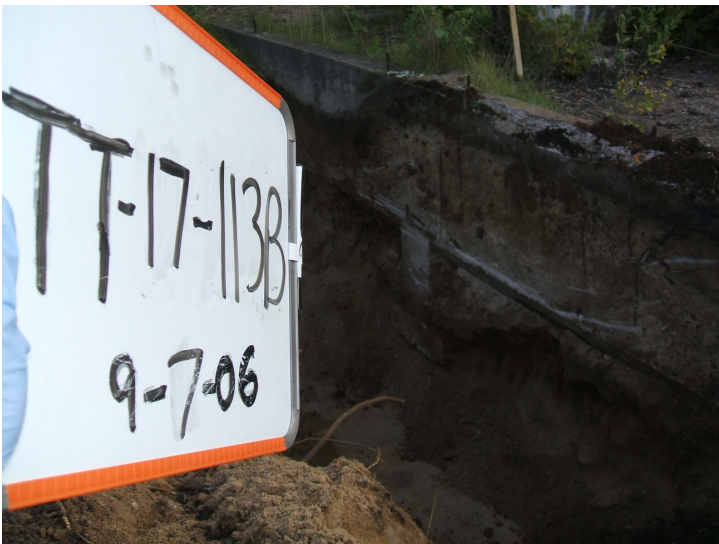
9/7/06: building footing along test trench 17 located along the southern portion of the west building wall.

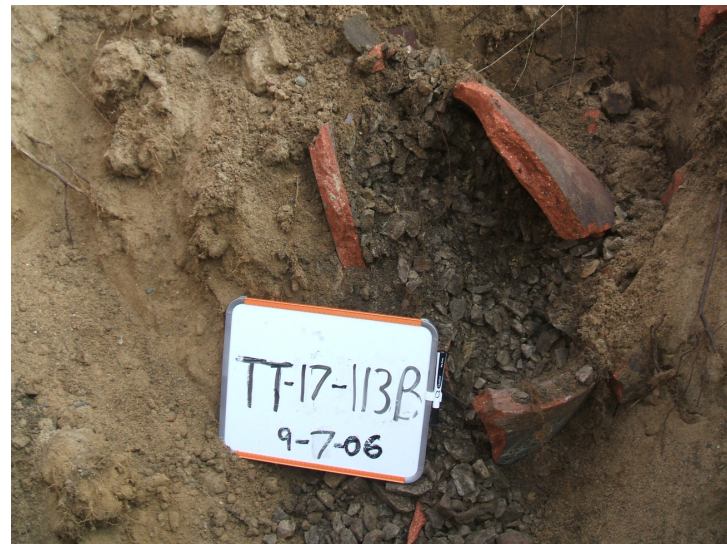
9/7/06: dry well discovered in test trench 17 in the southwest corner.

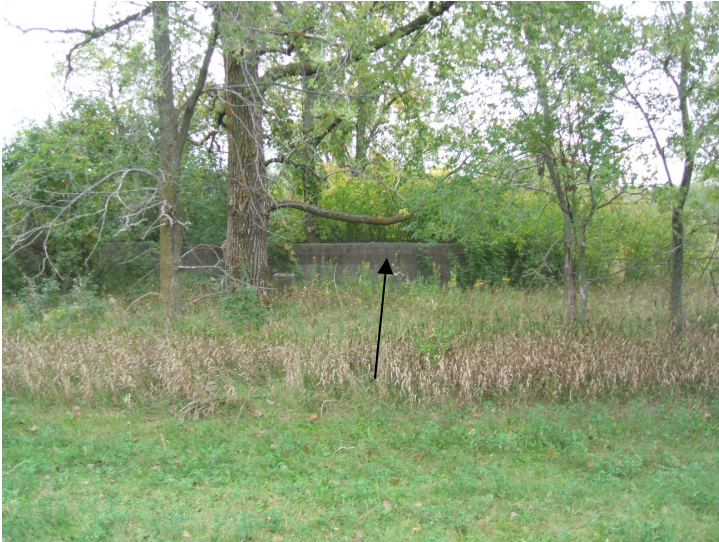
9/21/06: view facing east of concrete building remnant.

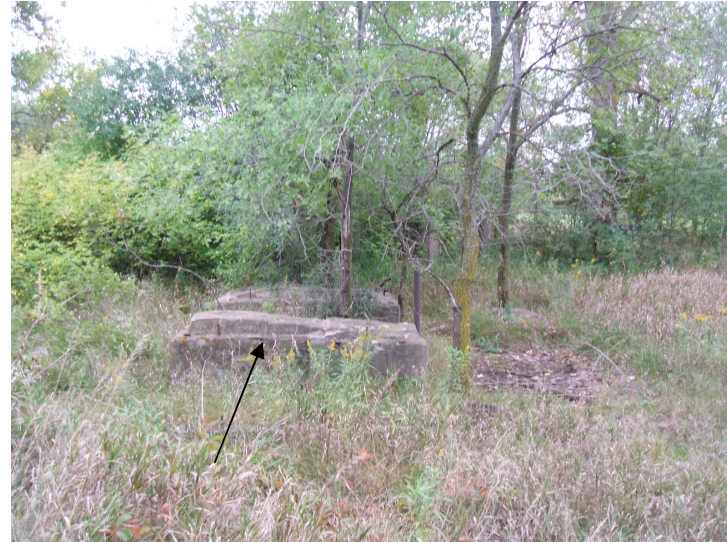
9/21/06: view facing south of concrete building remnant.

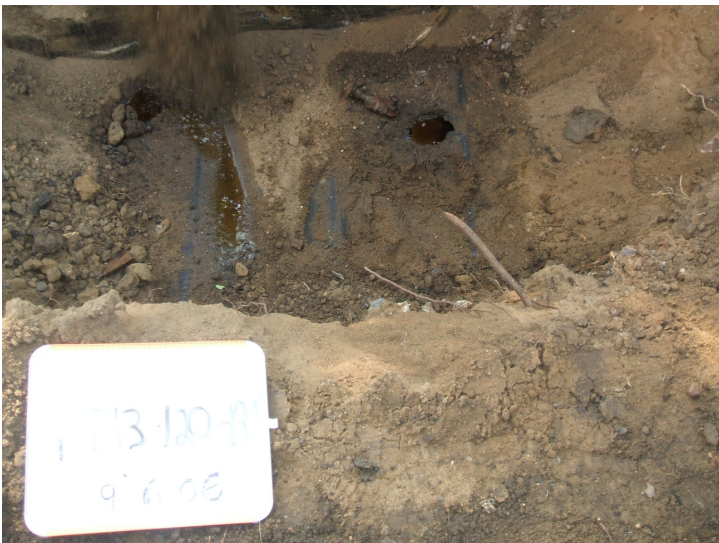
9/6/06: three cast iron pipes discovered in test trench 13 located on the east side of the building.

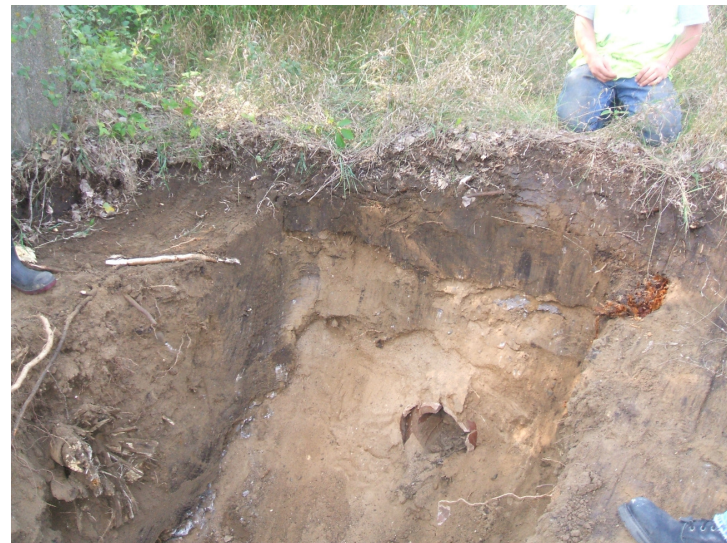
9/6/06: clay pipe discovered in test trench 13 located on the east side of the building.

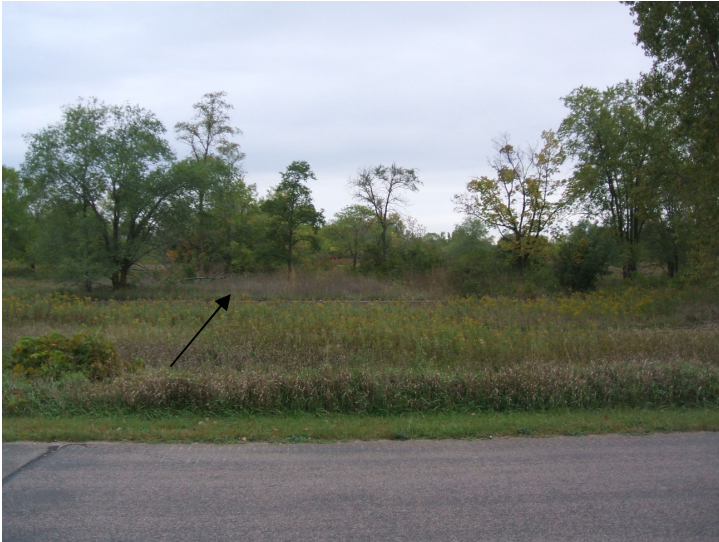
9/21/06: view facing north of concrete building pad hidden by foliage.

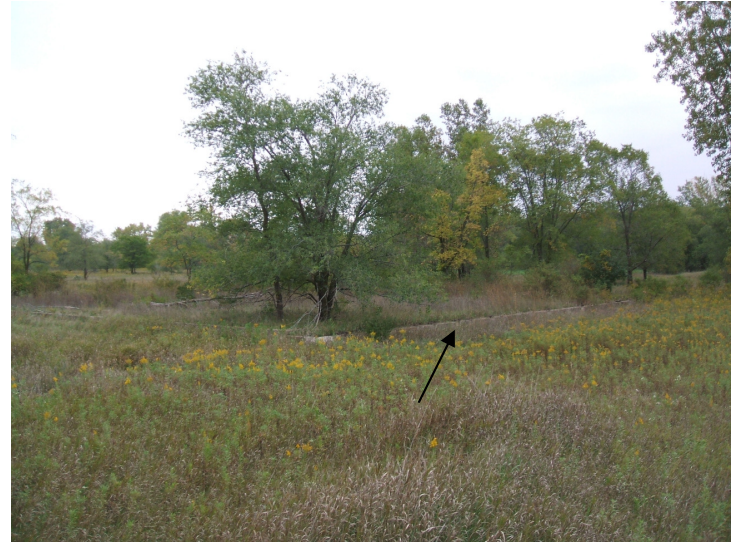
9/21/06: view facing northeast of concrete building pad.

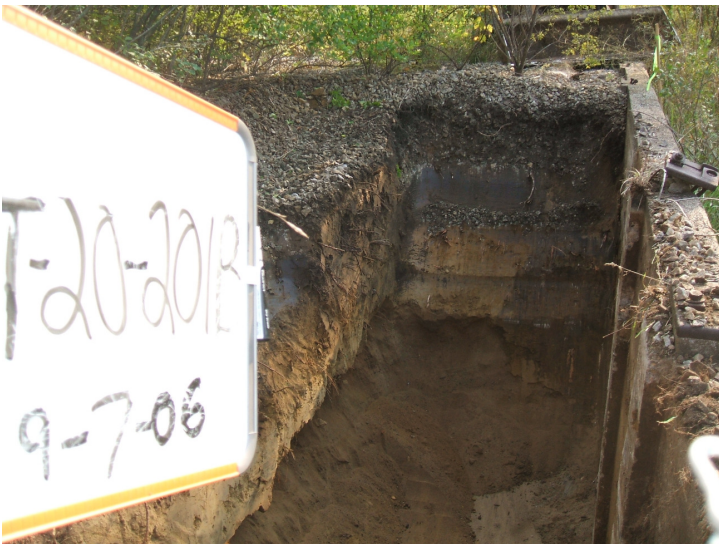
9/7/06: test trench 20 located at the northwest corner of the building.

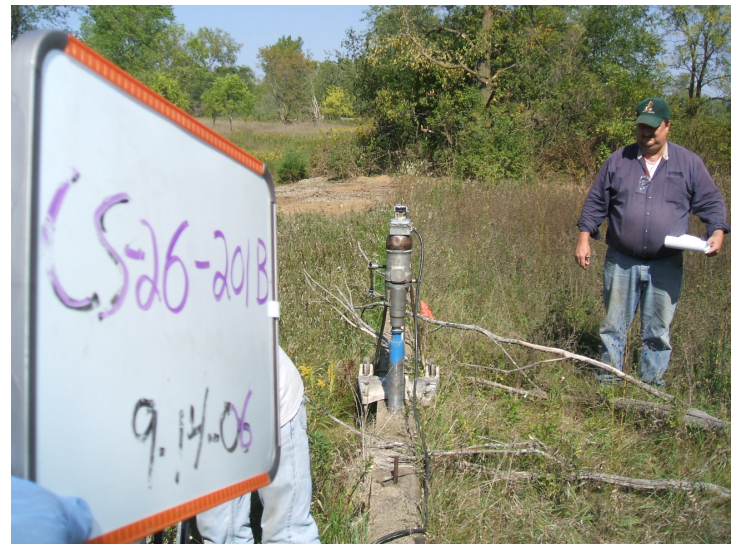
9/14/06: location of concrete sample 26.

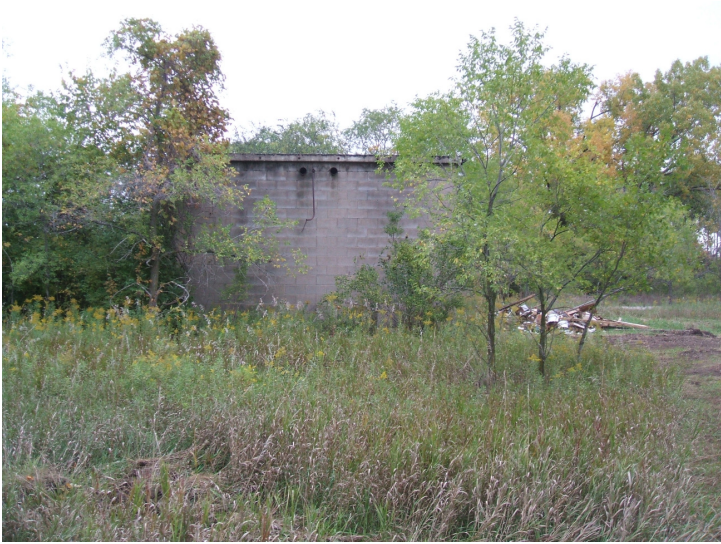
9/21/06: view facing north of building.

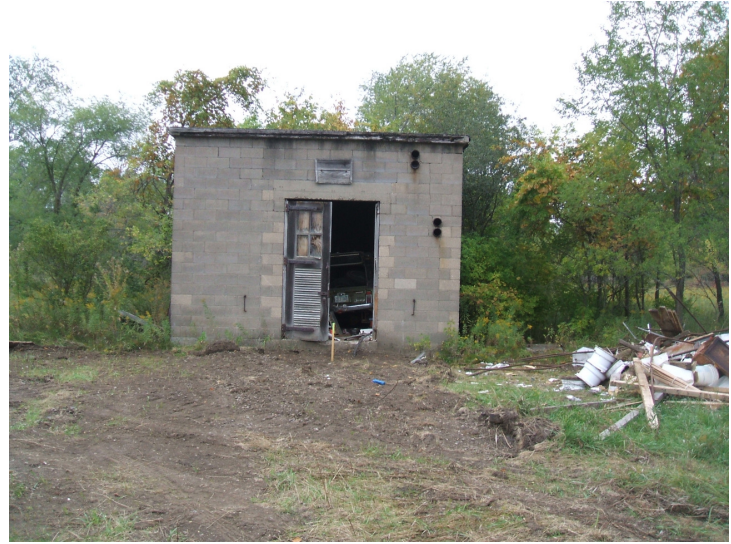
9/21/06: view facing west of building.

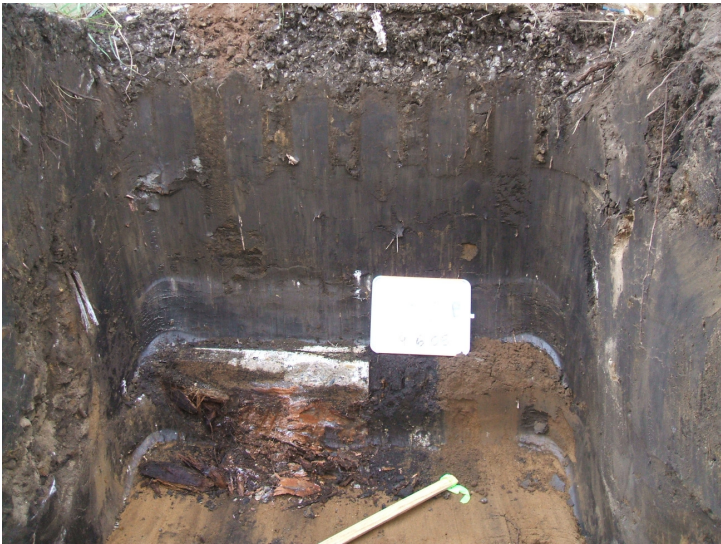
9/6/06: building footing along test trench 12 located on the east side of the building.

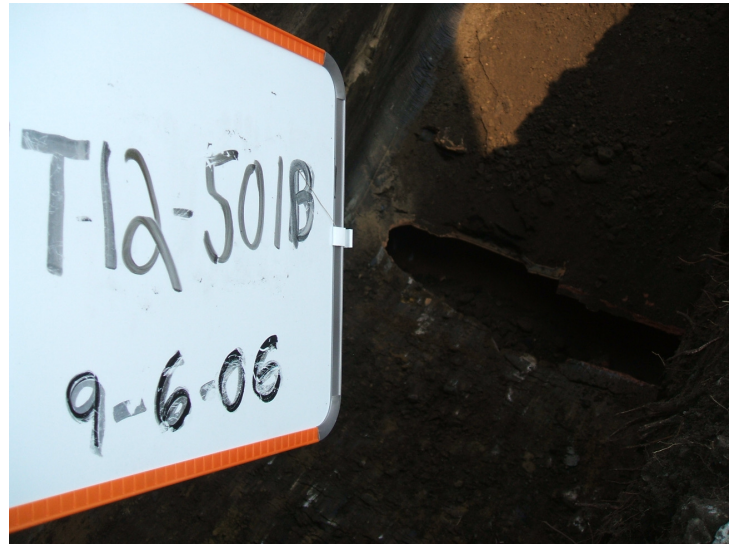
9/6/06: clay pipe discovered in test trench 12 located on the east side of the building.

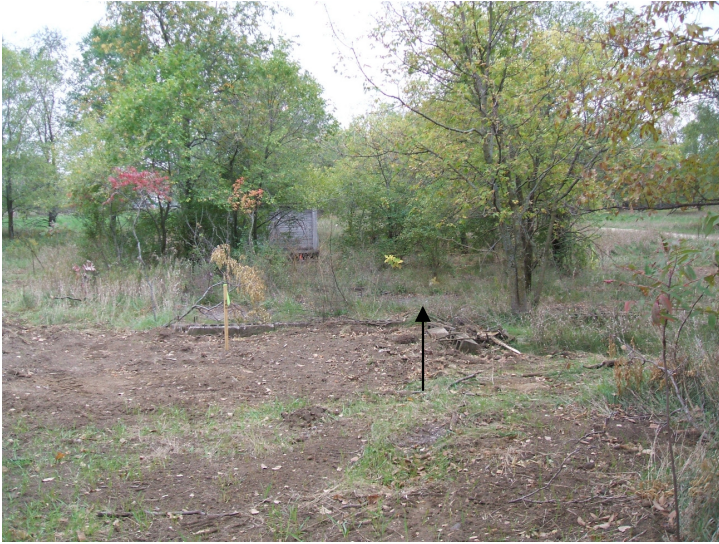
Building 706J, view facing south of concrete building pad.

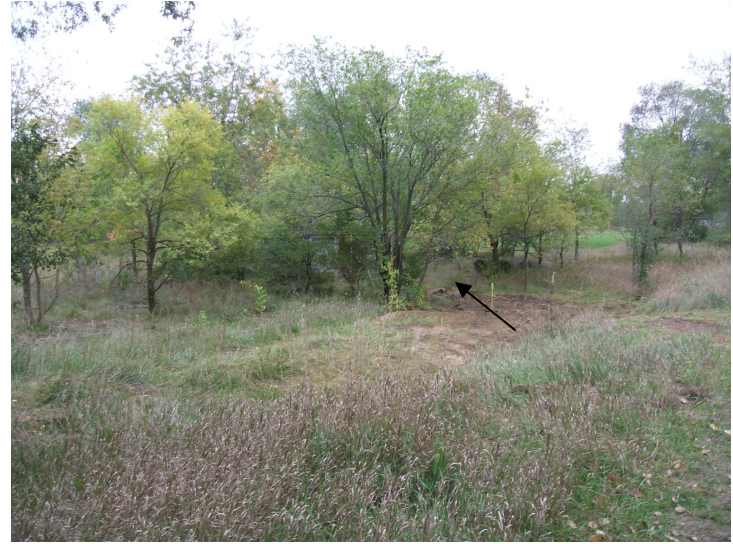
Building 706J, view facing southeast of concrete building pad hidden by trees.

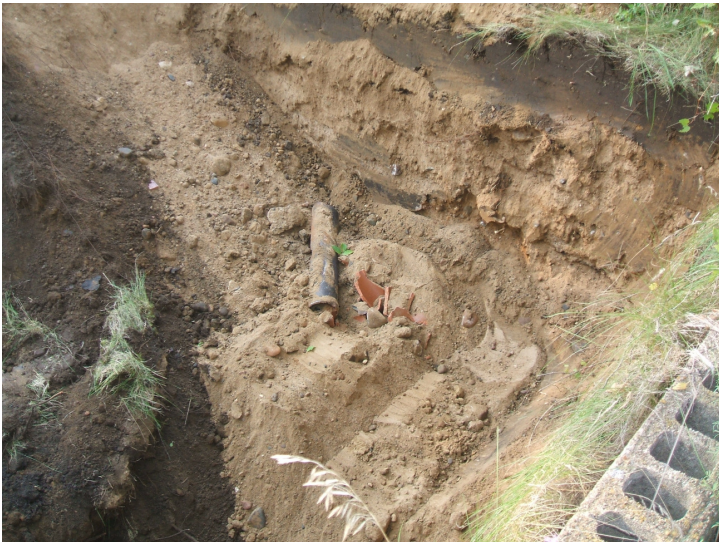
Building 706J, pipes discovered in test trench 15 located on the north side of the building.

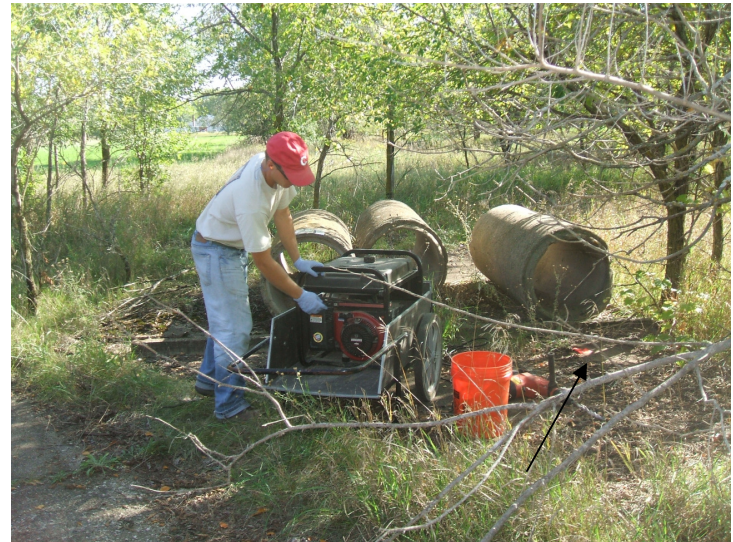
Building 706J, location of concrete sample 12 on the concrete building pad.

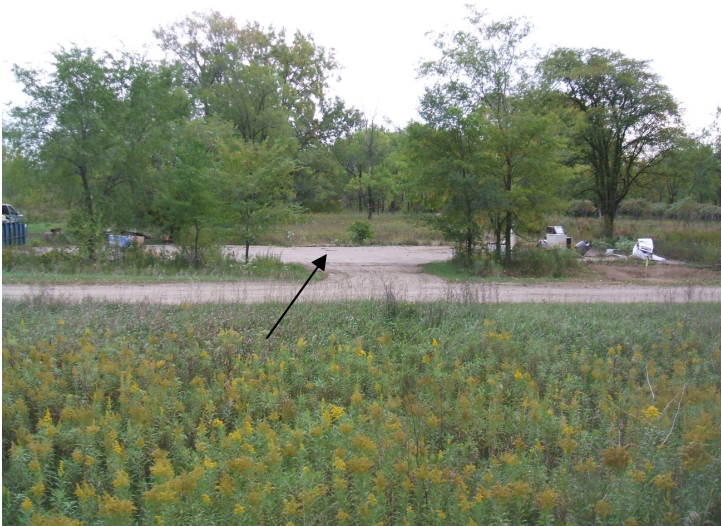
Building 722B, view facing east of the concrete building pad.
