Building 101B, East Guncotton/Nitrocellulose Production Area (A, B,C Lines)

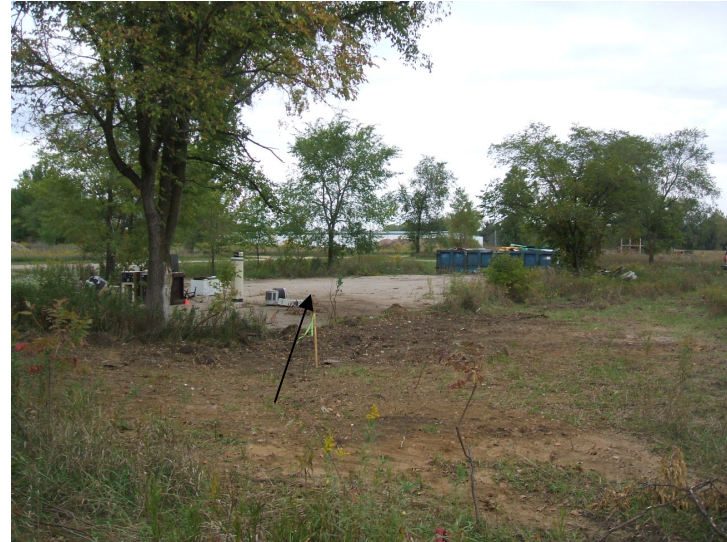
Building 722B, view facing northwest of the concrete building pad.

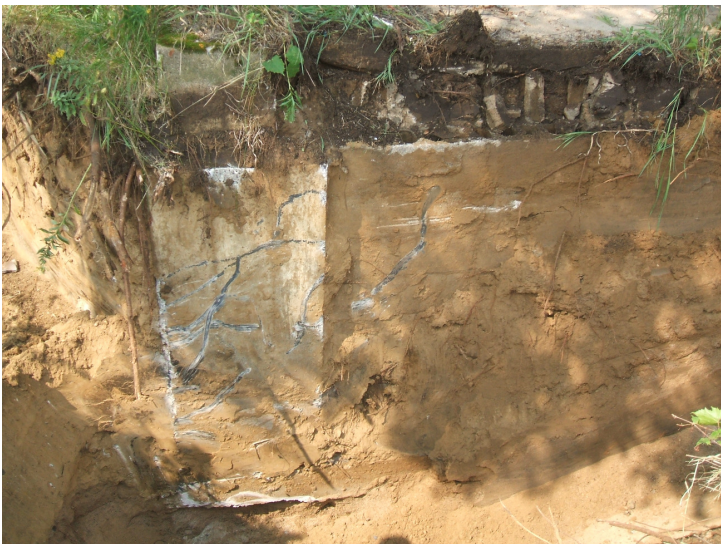
Building 722B, building footing along test trench 6 located on the southeast corner of the building.

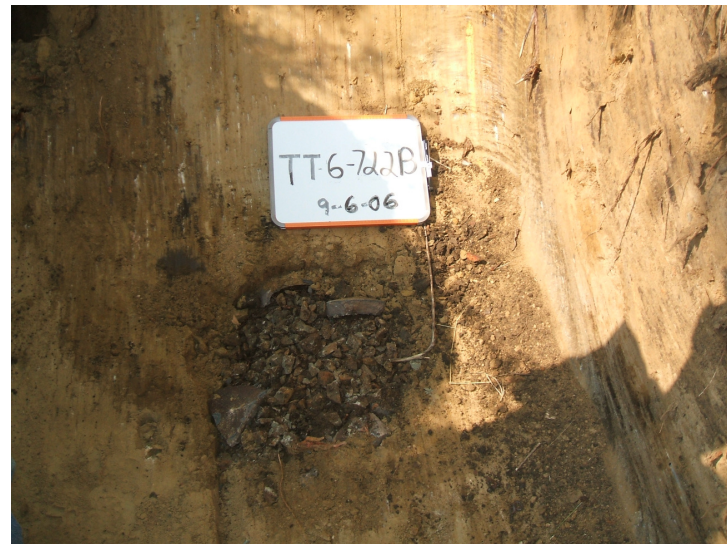
Building 722B, dry well discovered in test trench 6 located on the southeast corner of the building.
