## **Appendix A**

### **Historic Information: SOC's 4 and 5**

## **DNT IGLOOS – Site 5705**

### **Former Gopher Ordnance Works**

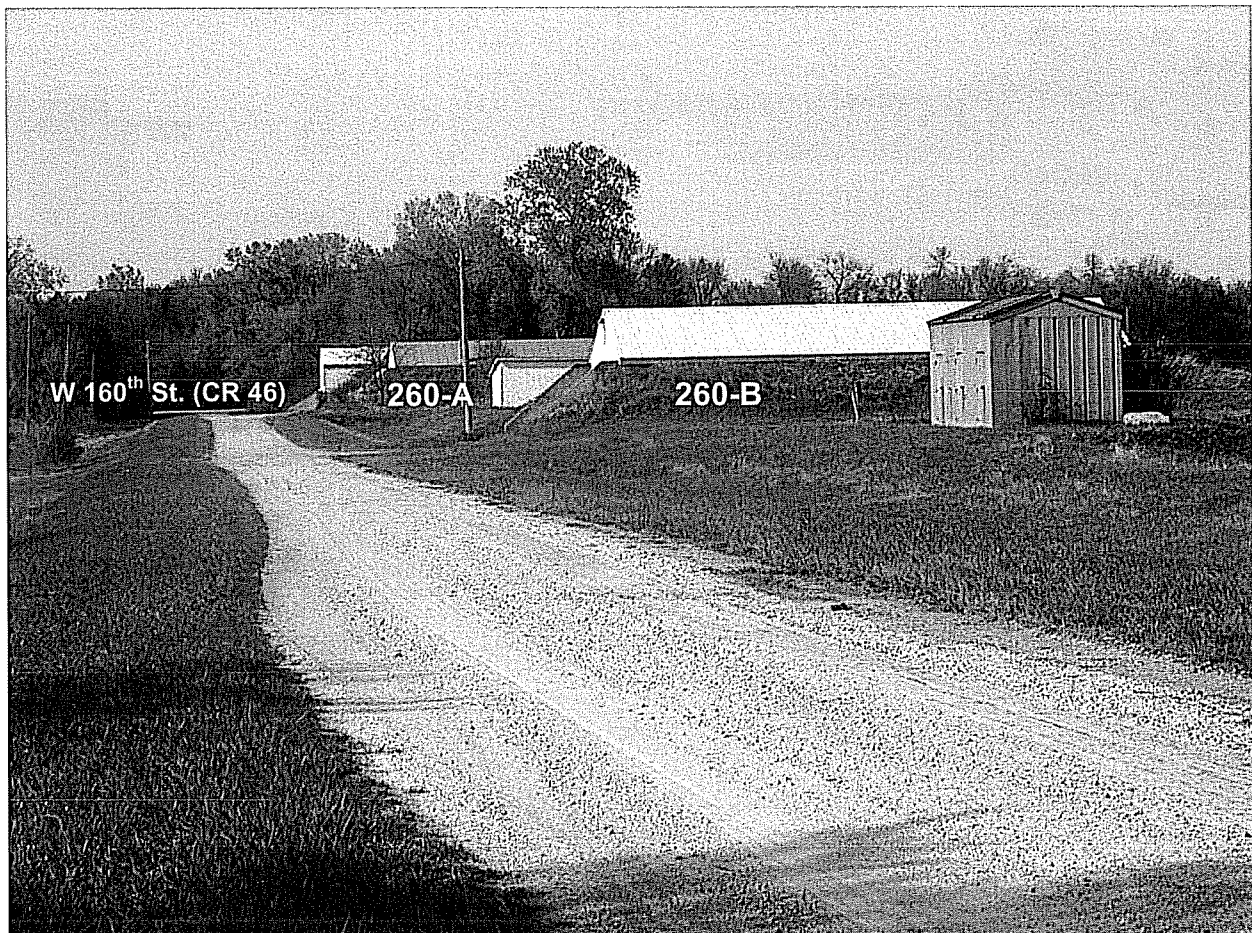
**Figure 1. View North of DNT Igloos 260-A and 260-B, UMore Park; Photo 2005**
