Updated Phase I Environmental Site Assessment Materials

Technical Memorandum

To: UMore File 23/19 0B05.03
From: Jim Aiken and Sara Gaffin
Subject: Site Visit Notes, Field Observations and Identification of Sites of Concern for Phase II Work Plan – 9/16-17/2008
Date: November 13, 2008
Project: 23/19 0B05 RIWP 200
c: Janet Dalglish, Steven Lott

Visual Site Reconnaissance - UMore Mining Area UMore Park, Dakota County, Minnesota

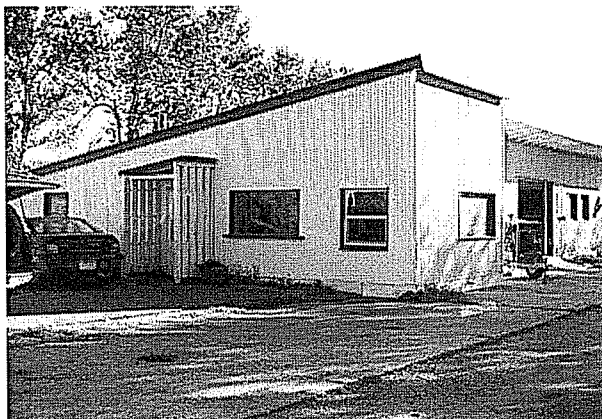
JSA 1 West Research Complex Site #6009

Office building 313 view to east.

Western Research Complex Site #6009 (Photo JSA1) – This area consists of six buildings and is known as Agronomy area. There was no evidence of a release or spill on the ground surface observed on or in any of the buildings. Building 315 is a pump house, 306 is used for equipment storage, and 313 has some chemical fertilizer and pesticide storage. An approximately 5 foot diameter concrete cistern cap with a 4 inch hole was observed northwest of 313. The interior of the cistern appeared to be about 8 feet deep and was dry. A septic drainfield was also observed north of the 313 building. The other buildings were locked and were not accessed. The ground surface around the building exteriors showed no indication of a release.

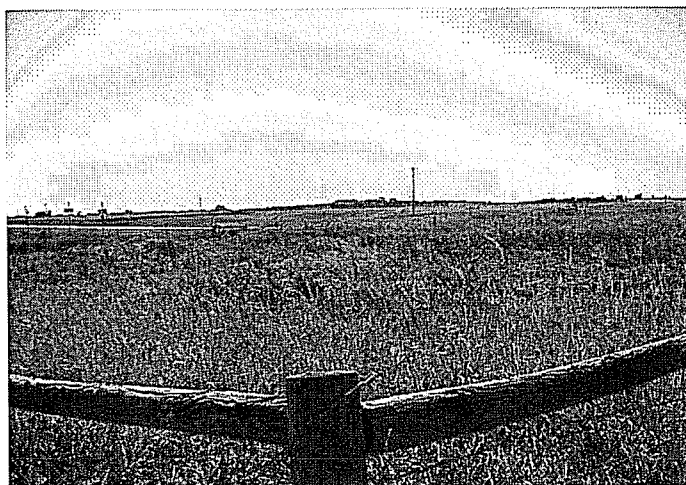
JSA 3 Ag Research LUST 7154 Site #5202

View to southeast from mapped location. It is likely that the LEAK site was about 300 feet to the south of this location.

Ag Research LUST Release; Site #5202 (Photo JSA3) – This area is an open grass land and bean field. No indication of any structure or foundation. Review of historical data indicates that this site is actually related to site #6011 (described below in regard to LEAK site 7154) related to the north residence for former Dairy Complex building 214/215 which was about 300 feet south of the location shown on Figure C-1.

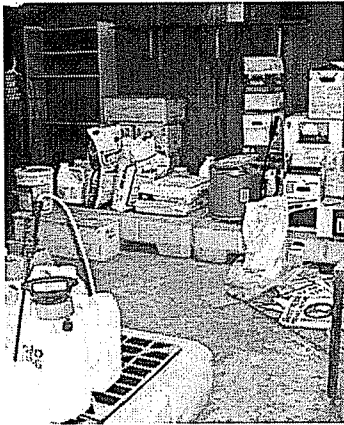
JSA 5 South Research Complex #5874 and #6007

Pesticide storage inside Bldg 709

South Research Complex Site #5874 and #6007 (Photo JSA 5) – Observed pesticide (fungicide) being loaded on south side of 701. Talked to Kimon Karelis of University, he said he was not aware of any previous releases, described some of the on-going research, and provided access to the buildings on the southern complex buildings. Pointed out the drainfield south of the building 703 office and indicated that the pole barn was newer. I asked about the shallow depressions west of the old pump house – he indicated that was an old wild rice test plot operated about 20 years ago. He thinks that it is lined to keep water in it but has not noticed it being particularly wet after rains. Building 702 is an old pump house that is no longer used, but is not believed to have been decommissioned.

Building 709 is divided into two parts, with pesticide storage on south side and equipment storage/possible well pump house on the north side. There is a concrete wash pad that slopes to southwest onto a grassy area where there was at one time a 1500 gallon pesticide UST (AgSpill #14389). There is a strong pesticide odor inside. Noted an old wash basin with the drain disconnected. May have been connected to a capped sewer pipe riser in the floor with drainage to the tank or the septic located to the southeast near the office (Building 703).

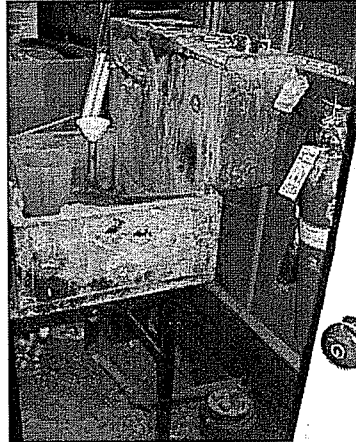
Wash basin inside Bldg 709

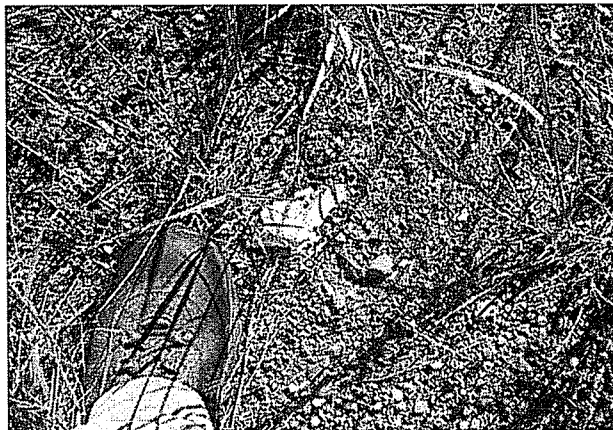
Partially buried vinyl and fabric debris

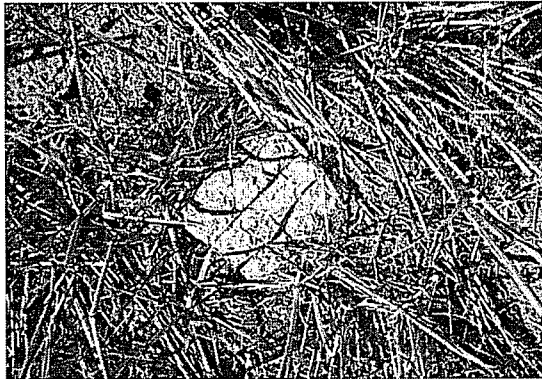
JSA 8 Suspect Disposal Areas near former Dairy Complex; Sites 5152, 6013, 6010

Concrete Debris on West side of 5152 area.

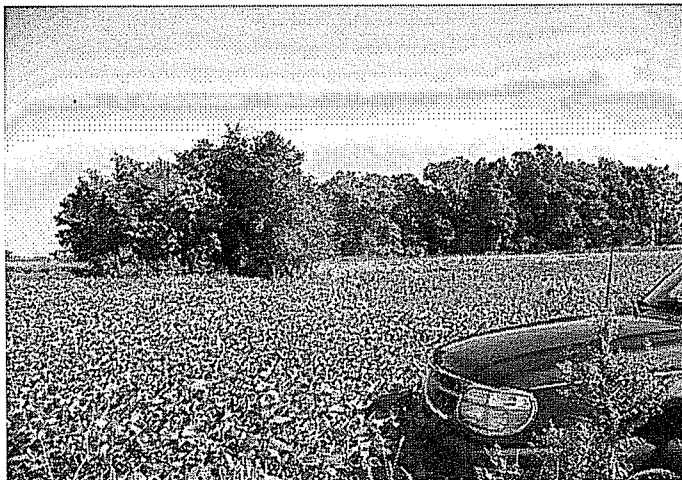
JSA 9 Abandoned JA Hynes Farmstead and old Manure Pit; Sites 5891 and 6012

Location of old Farmstead looking east.

Abandoned JA Hynes Farmstead and suspected former Manure Pit; Sites #5891 and #6012; (Photos JSA 9) – This area was moderately wooded with no evidence of former farmstead. The manure pit is inferred from 1964 air photograph which shows new construction and ditch or path south from Dairy Complex. The basin has an eastern and western sub basin separated by a berm. Area is heavily wooded to grassy. An eight inch pipe fiberglass reinforced enters from the north at the berm into the western basin at about 10 feet below grade. The eastern basin is apparently fed by a 16 inch corrugated steel culvert about 15

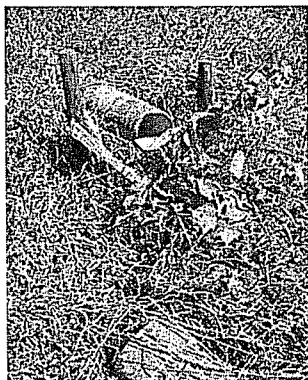
Close up of west pipe.

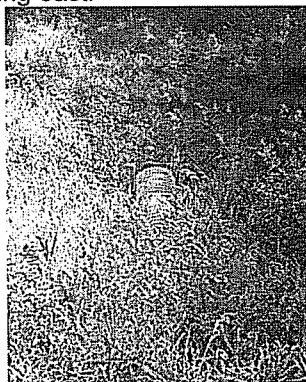
16 inch culvert leading to east basin.

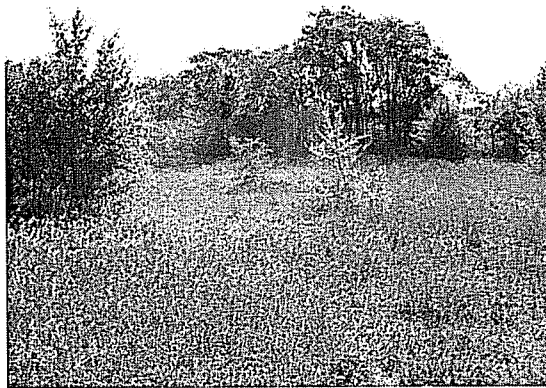
Former turkey carcass dump east of Poultry Research (east of UMA boundary).

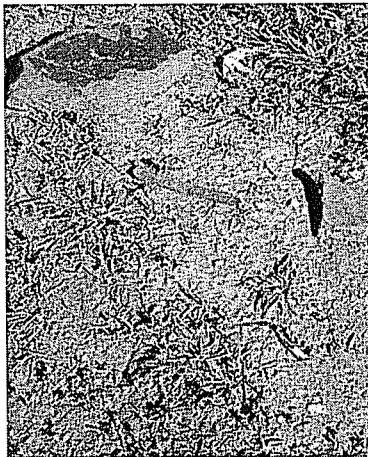
JSA 11 Forestry Research and old GOW storage along rail line -#6004, #6005, 5262 and 5263

Close up of surface debris in north portion of Forestry Research area.

Conducted a detailed traverse through both the wooded areas in a cornfield to the east. The supply yard was located to north and this was a loading/unloading area for GOW with a series of store houses and support buildings shown on old maps. There was a significant concentration of concrete and gray cherty facia stone in the surface soil in the cornfield to east. No evidence of a release except for the potential for rubble fill soils. Found a railroad tie in woods to south and scattered fugitive-type dumping debris in wooded area. The access road into the area is scattered with concrete fragments, bits of metal, and vitrified clay pipe – suspect disposal area or graded fill.

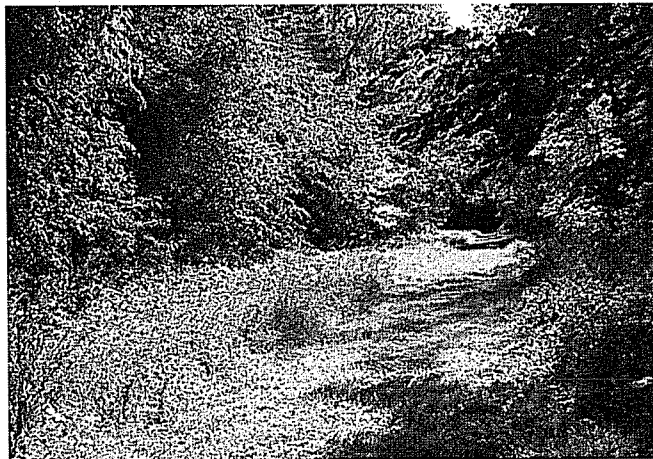
View to south of Forestry research area.

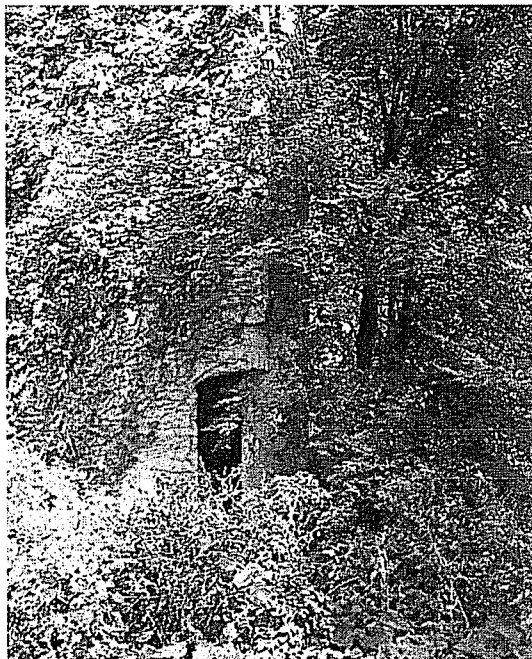
JSA 12 Rental Home and former Wetterlund Farmstead #5878

Base of old silo on north side of property.

Rental Home and former Farmstead #5878 (JSA 12) – Currently a single family home. Well noted in front yard. Old concrete silo in wooded area to north, some junk in the yard, no evidence of release. Also traversed area to east shown on maps to have other unknown storage structures. No indication of release.

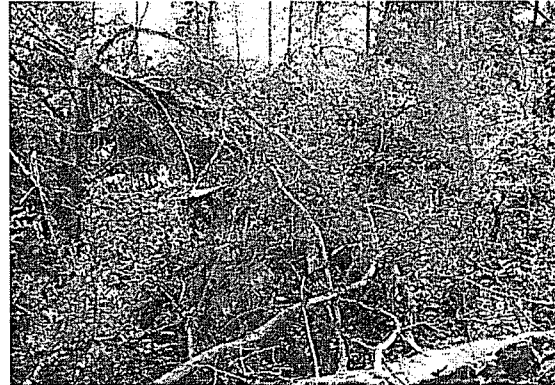
SZH 1 Former K Street Dump Site 5225

View of debris obscured by heavy vegetation.

Former K Street Dump #5225 (Photo SZH 1) – This area is currently wooded with some rubble visible on the ground surface. Debris was obscured by heavy vegetation during the site visit. The extent of the dump is distinguishable in aerial photographs and in the field by the higher topography and a change in vegetation from surrounding areas. According to information provided by Dakota County, the dump was likely a borrow area for GOW and was filled with GOW demolition debris. The dump was encountered during construction of County Road 46 and the northern limits of the dump are reportedly located in the south right-of-way.

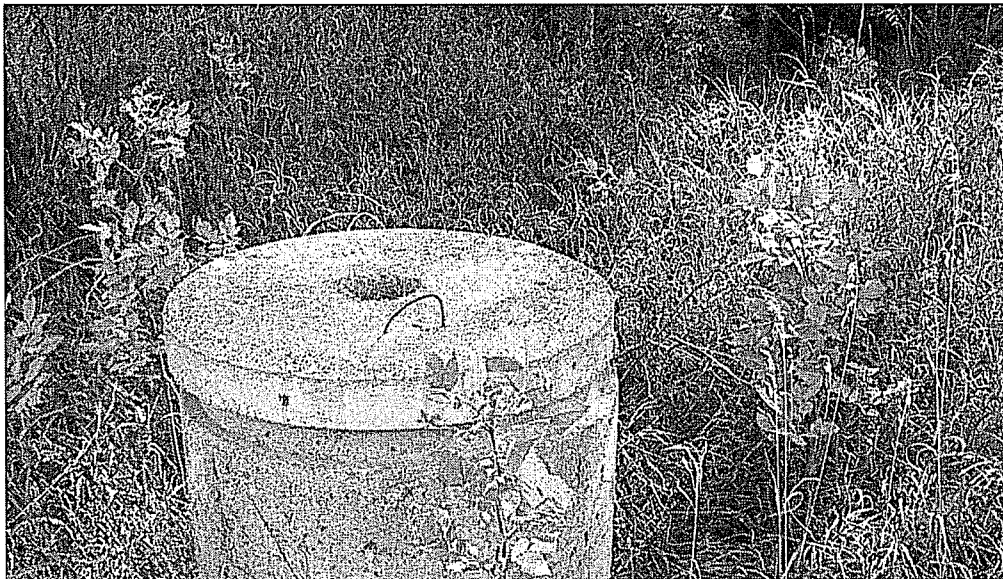
SZH 2 Ag Engineering Complex, Former Waste Lagoon Site 5012

Concrete cistern in former animal waste lagoon west of K street dump area.

Ag Engineering, Former Waste Lagoon #5012 (Photo SZH 2) – This area is currently vacant grassland with sparse small trees and is topographically lower than surrounding areas. According to staff interviewed onsite, the area was used as an animal waste lagoon. Building 1006 was formerly a poultry barn and a manhole on the southwest building corner reportedly drains to an outlet pipe observed in the lagoon during the site reconnaissance. An approximate 3-foot diameter concrete cistern raised approximately 2.5 feet above ground surface was observed on the eastern side of the lagoon.

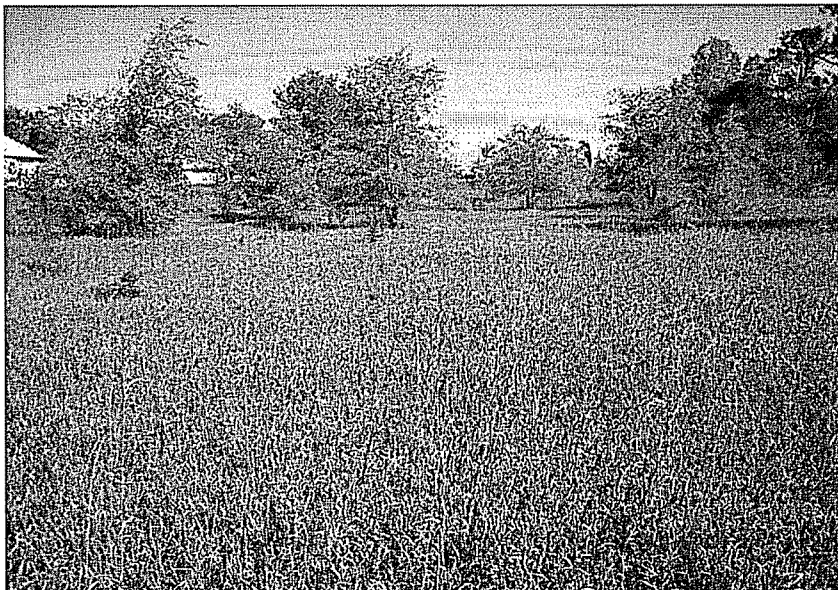
View to north of former chicken waste lagoon located south Ag Engineering Complex

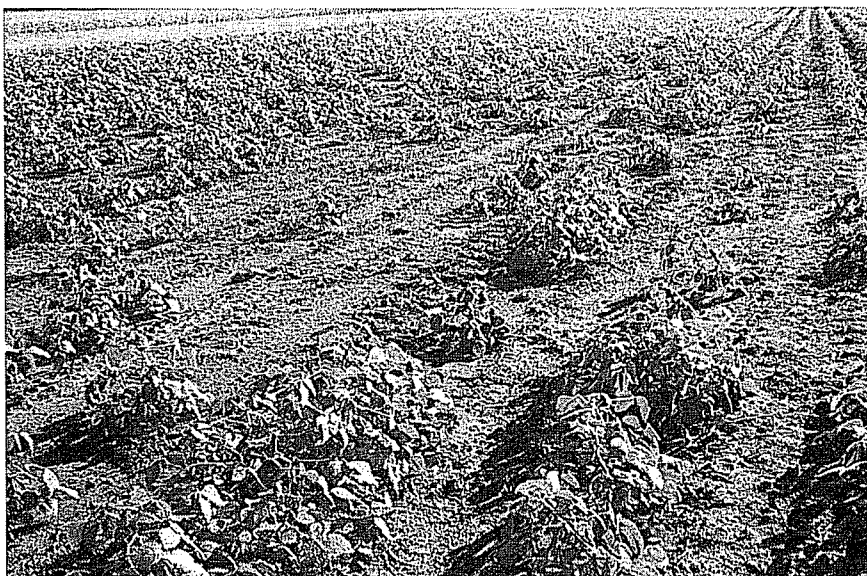
SZH 3 - 6015 Building Remnants south of Ag Engineering

View to south of remnant building locations, note poor plant density.

Former GOW Building Remnants #6015 (Photo SZH 3) – No buildings or foundation remnants were observed during the site reconnaissance. Locations 263-C, 724-H, 707-T, 707-W, 722-P, and 220-N were inspected (Figure C-2). The area is planted with peas and ground surface visibility was good to fair based on the crop heights during the time of the site visit. Vegetation was sparse near former building 220-N.

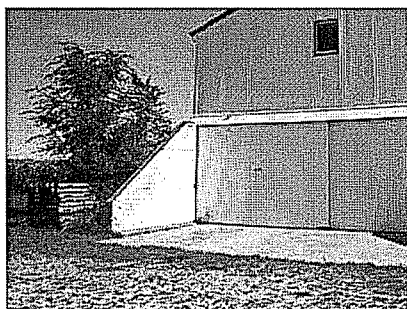
SZH 5 - Central Services 5705, 5011

Exterior view of former DNT storage bunker now used for storage.

Central Services #5705, #5011 (Photo SZH 5) – Central Services is the location of twenty-two buildings, including eight former DNT igloos (Site 5705). The DNT igloos were historically used for storage of explosive chemicals and gunpowder. Based on the site reconnaissance, the current building uses are as follows: maintenance garage (610); grain elevator and silos (624); truck scale (620); pump house (625, south of 620); chemical storage areas (606, 611); storage for agricultural equipment, crops, supplies, and products (602, 603, 604, 605, 607, 608, 609, 612, 615, 617, 618, 619, 621, 623); and office/research space (601, 622). Minor staining was observed on the concrete ground surface in Buildings 602 and 611 (see Photo). Three ASTs used for storage of diesel, unleaded fuel and used oil were observed near Buildings 622 and 610. The ASTs were located on concrete pads and no evidence of recent spills or staining was observed on the ground surface surrounding the tanks. Vent pipes possibly associated with a septic system were observed east of Building 610. Four propane tanks and an approximately 3-foot diameter cistern were observed east of building 619. The interior of the cistern was moist and an outlet pipe into the structure was plugged with a water bottle. 2-inch diameter vent pipes were also observed south of building 624. Most of the buildings were locked and were not accessed during the site visit. Except as noted above, there was no evidence of a release or spill on the ground surface observed on or in any of the buildings inspected.

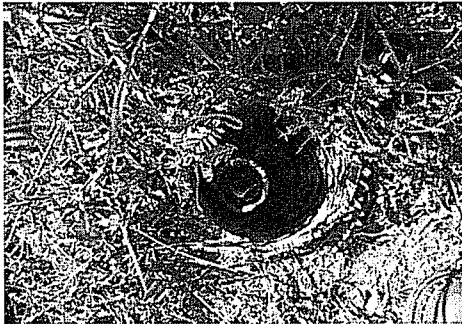
Former monitoring well location near past pesticide tank release area.

Dakota County Site ID #5011 relates to a pesticide release discovered during removal of a former rinsate UST located south of Building 621. During the site visit, fill was visible in the location of a former corrective action excavation near the former pesticide rinsate lagoon (see Figure C-2) and an abandoned monitoring well was observed south of Building 621. According to a report prepared by Peer in 2001, corrective actions and several additional investigations were conducted in the 1990s and early 2000s in response to the pesticide release. According to the Peer report, impacts from the release migrated in an easterly direct and pesticide concentrations showed stable or generally decreasing trends. Building 621 and the surround area is currently used for storage of gardening and landscaping supplies.

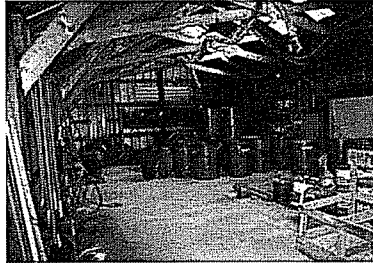
Petroleum storage inside Building 611. Note staining along left edge of floor slab.

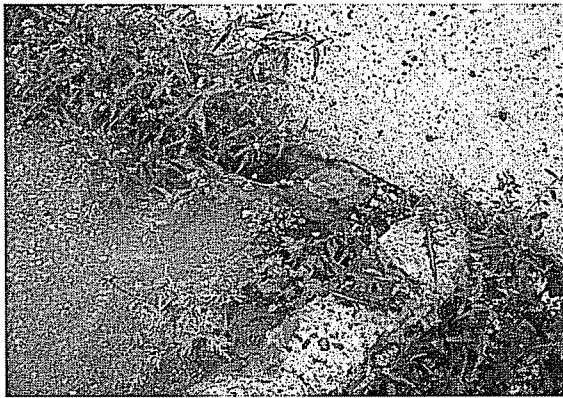
Interior drain gutter and French drain/sump (also known as dry well) in corner of partially demolished DNT storage bunker.

All of the igloos were constructed with open 6-inch gutters on the north and south sides of the building interiors that drain towards dry wells/sumps located on the west side of the gutters (see Photo). The gutters and sumps were observed in the accessible igloos during the site visit (Buildings 602, 603, 604). According to Dakota County information, the sumps are vertical 6-inch diameter tiles set three feet below ground and filled with gravel. No other floor drains or drainage systems were observed in the igloos

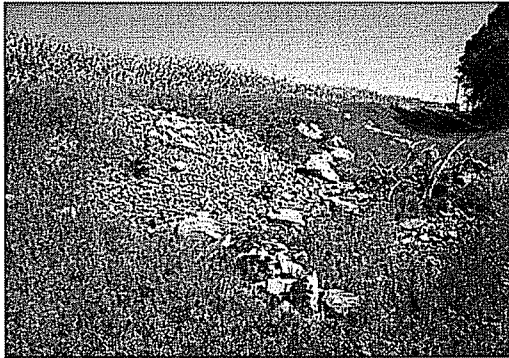
SZH 6 - Debris in Ditch off of AOC3 -DA1 south of AOC 5.

Debris in drainage ditch. This drainage is part of AOC 3-DA1 investigated in Army FSI.

DNT West Drainage Ditch #5706, AOC-DA1 (Photo SZH 6) – The drainage ditch reportedly received surface drainage from both the DNT igloo area and the DNT unloading platform. The ditch opened into a depression that acted as a stormwater retention pond and infiltration basin south of the Central Services area. Concrete rubble, field stones and other miscellaneous debris was observed in the southwest portion of the ditch. The location of the former retention pond is currently planted with corn and could not be inspected during the site visit. No evidence of stressed vegetation was observed along the ditch.

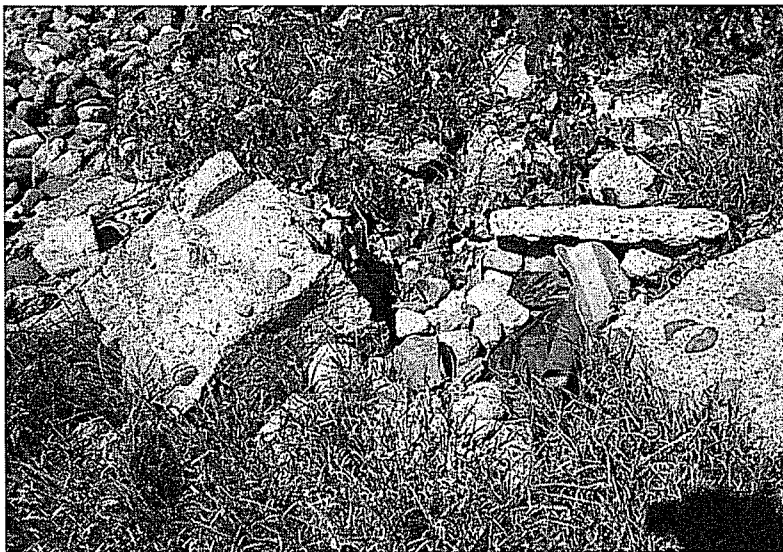
Close up of rubble debris in drainage ditch.
