APPENDIX C
PHOTOGRAPHS

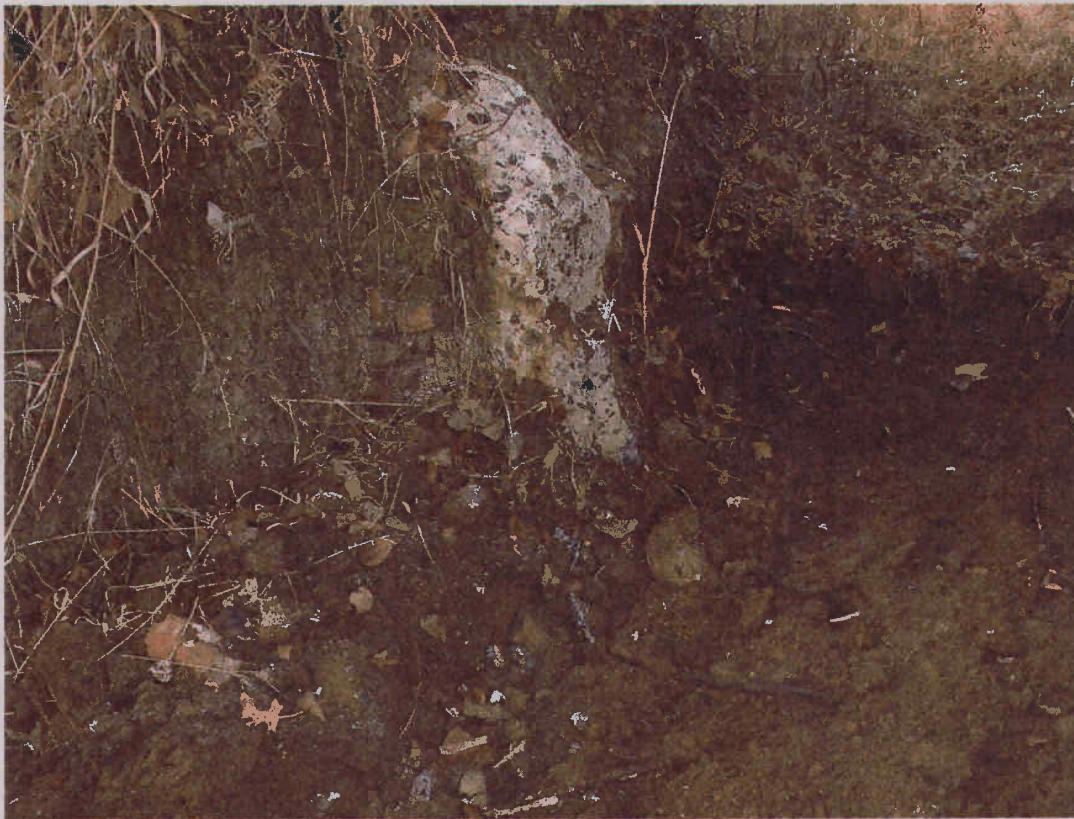
Oleum Plant Area. View of test pit OP-TP-1 showing the base of the sulfur mixing pit which is 2 feet below current grade. The base of the sulfur mixing pit is brick and the walls are constructed of poured concrete.

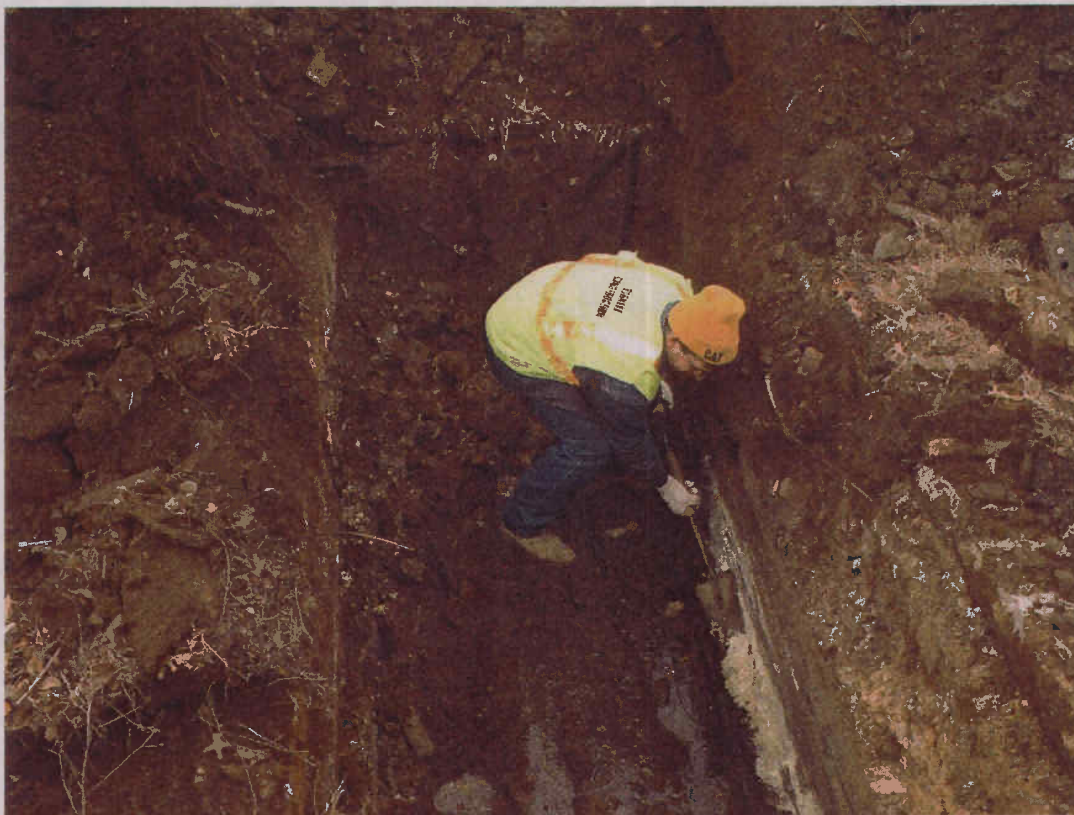
Oleum Plant Area. View of test pit OP-TP-2 showing the base of the sulfur mixing pit. Note the 6 inch layer of sulfur product at the bottom of the mixing pit.

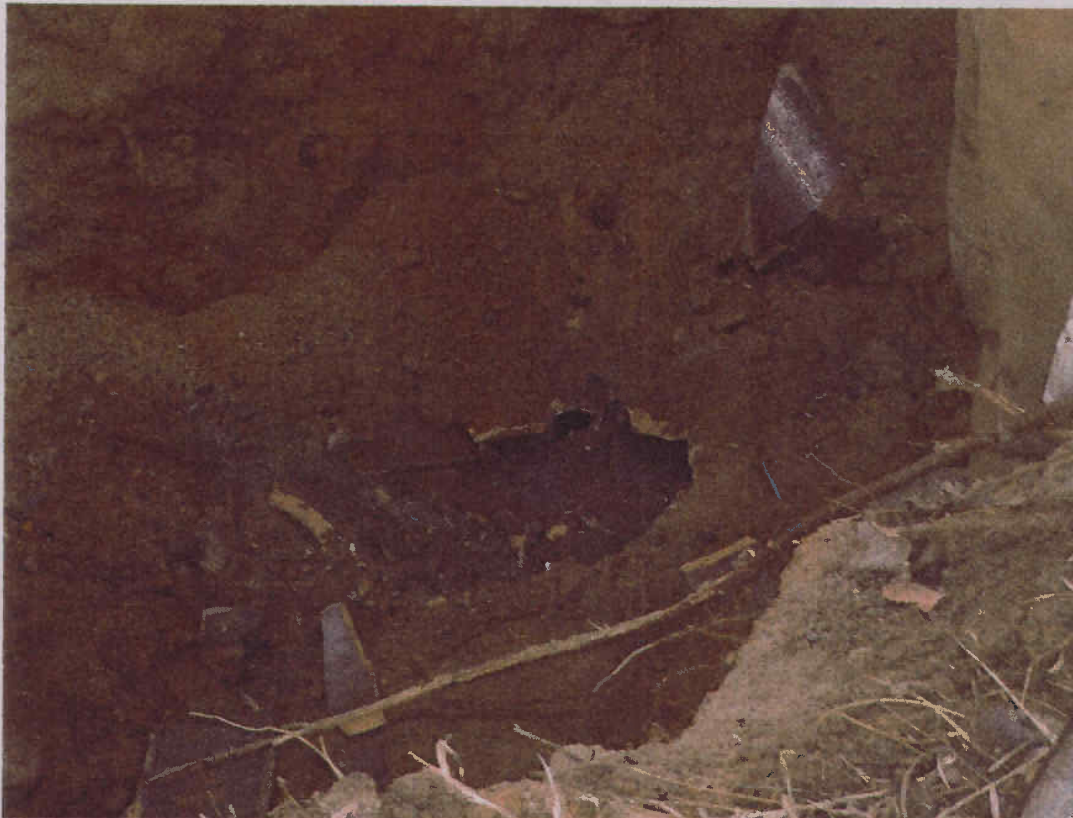
Nitric Acid Plant Area. View of test pit NA-TP-3, which was completed around a brick structure which accessed a buried clay drainage line associated with former above ground acid storage tanks.

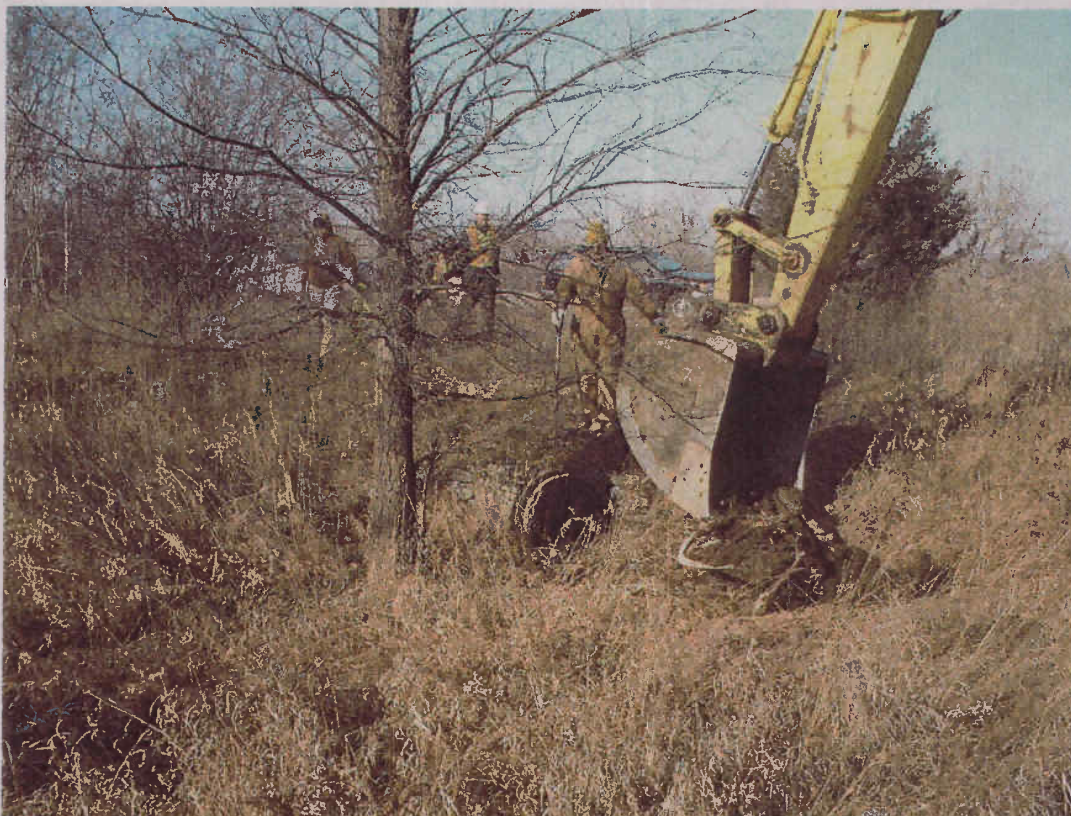
Nitric Acid Plant Area. View of test pit NA-TP-2 which was completed adjacent to the south open end of a wooden drainage culvert that runs under 152nd Street.

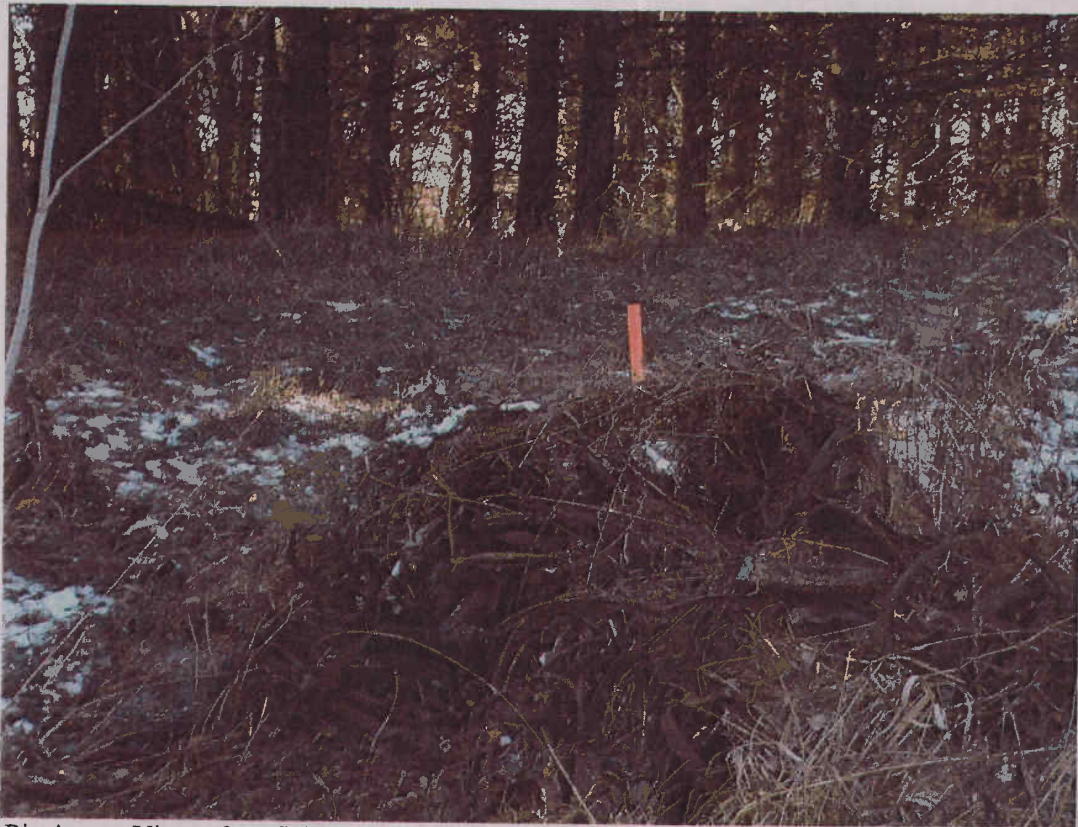
Burn Pit Area. View of surficial "Keystone" drum components (wood pieces, metal bands, and lids) observed at the location of test pit BP-TP-10.

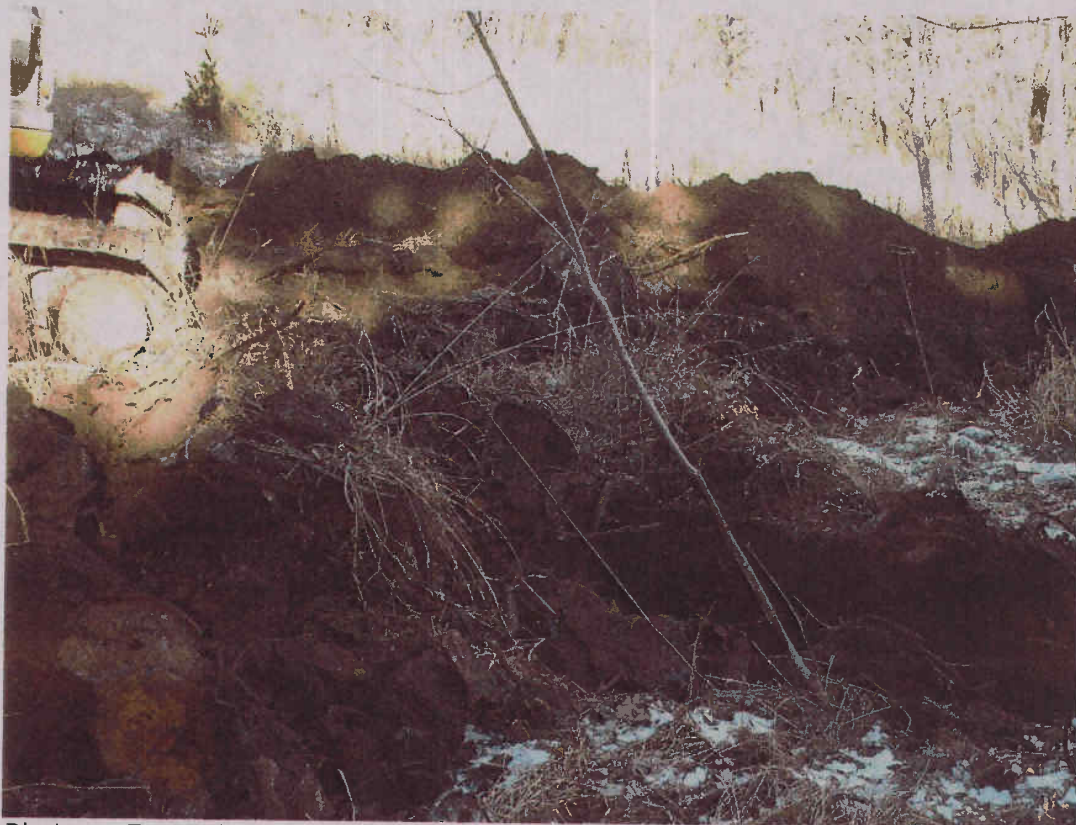
Burn Pit Area. Excavation of test pit BP-TP-10 which confirmed the drum components at this location are surficial.

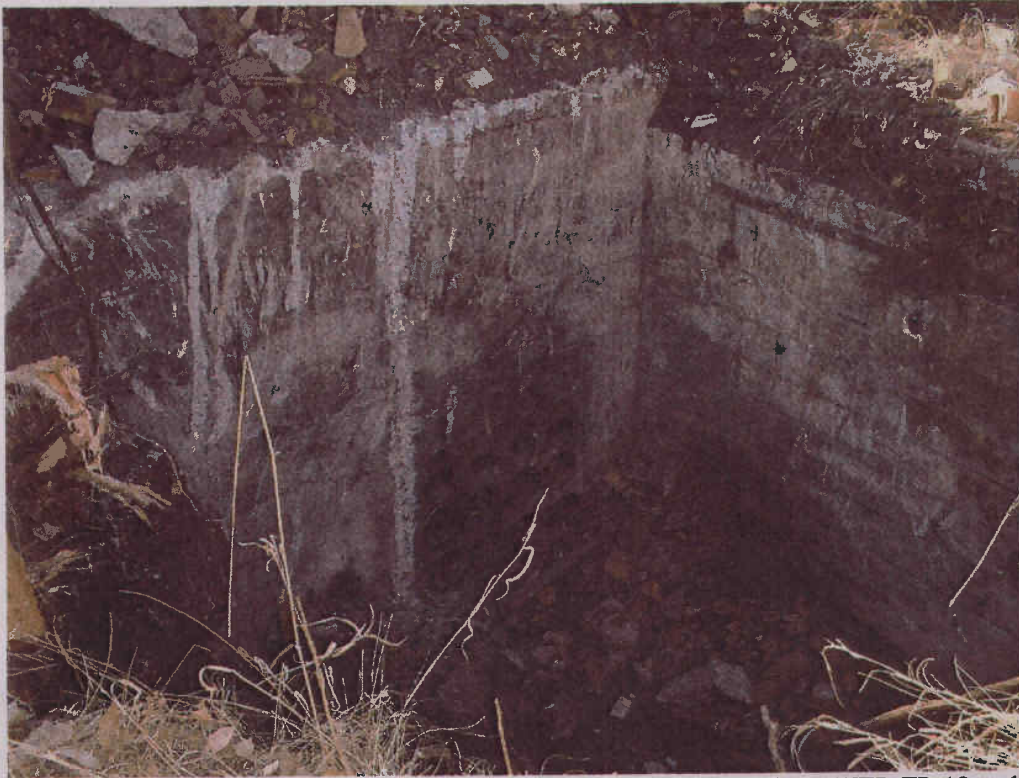
Wastewater Treatment Plant Area by Power Plant A. View of test pit WWTP-TP-12, which was excavated within a subsurface concrete water holding tank. The tank was filled with soil and debris.

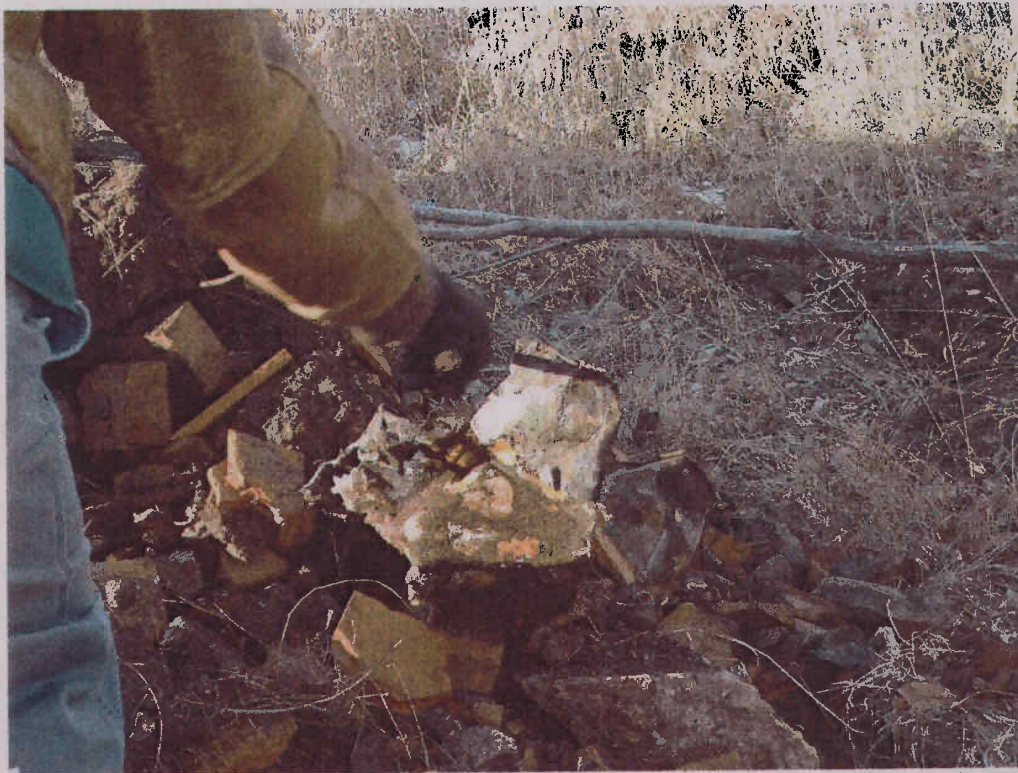
Wastewater Treatment Plant Area by Power Plant A. View of debris removed from test pit WWTP-TP-12 which included brick, slag, metal, tar, transite board, and electrical components.

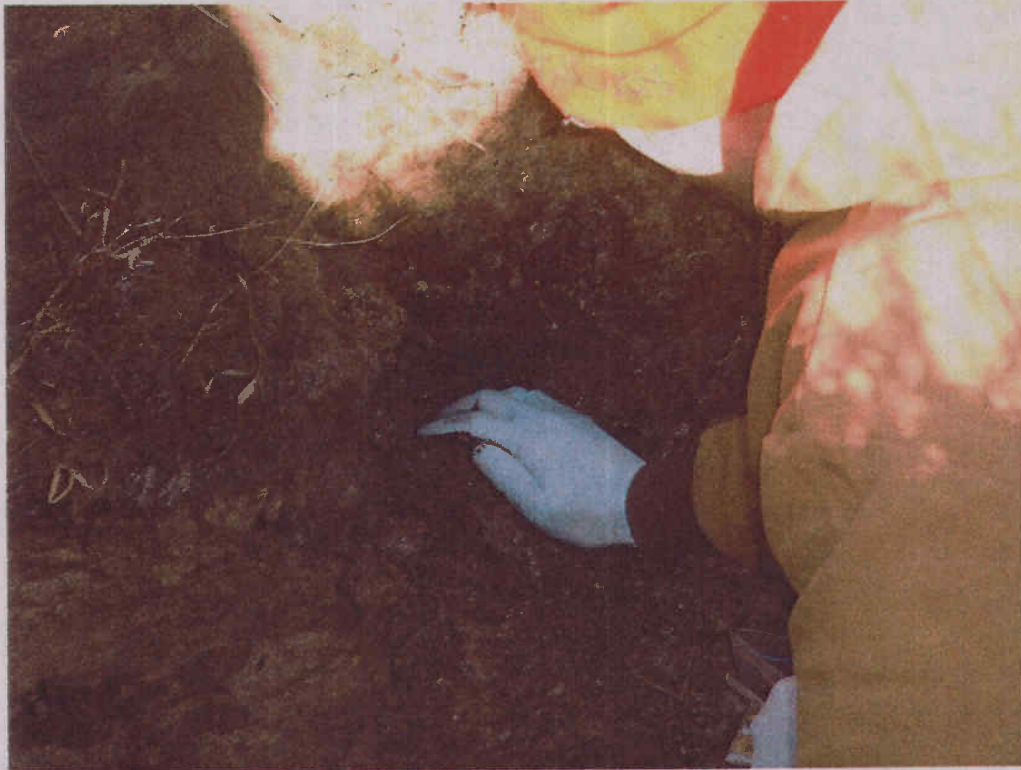
Drainage pond in Wastewater Treatment Plant Area. View of test pit WWTP-TP-19 showing six inch thick layer of fine, gray-black sediment buried at a depth of 1 foot. Material contains 420 mg/kg total mercury.

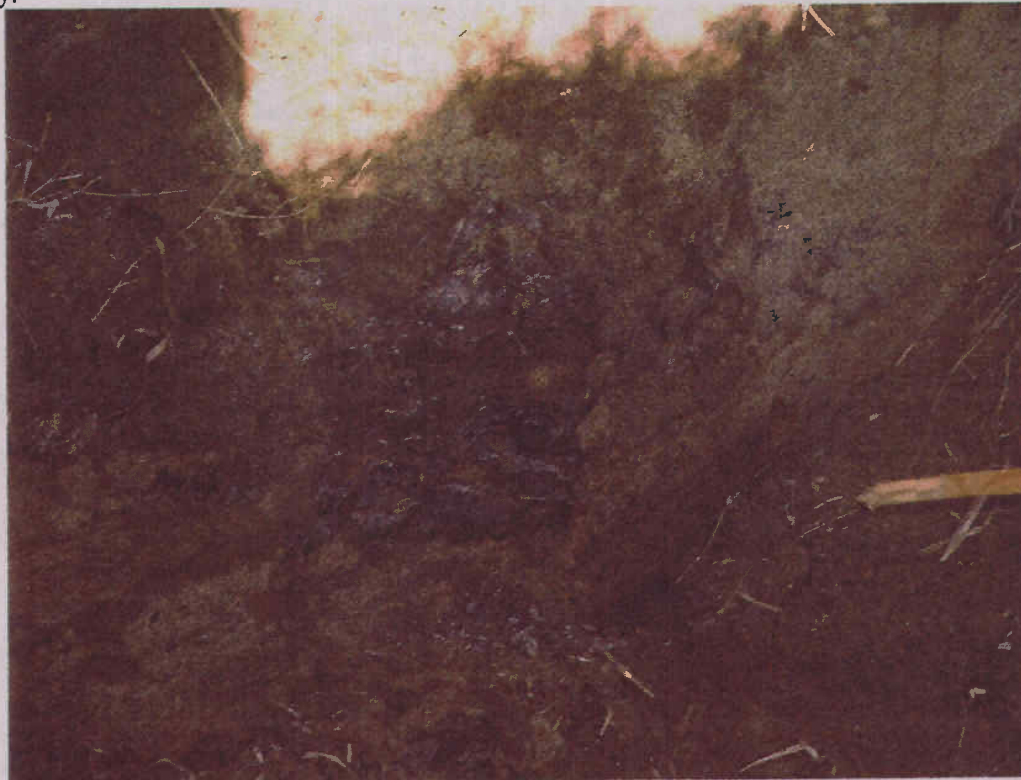
Drainage pond in Wastewater Treatment Plant Area. View of test pit WWTP-TP-20 showing six inch thick layer of fine, gray-black sediment buried at a depth of approximately 2 feet. Material contains 590 mg/kg total mercury.
